## Jamaica Civil Aviation Authority

### Aviation Occurrence Report Number JA-2021- 01

**AVIATION OCCURRENCE REPORT**  
**ROCKY POINT- CLARENDON**  
**SABRELINER 60 - REGISTRATION XB-JMR**  
**JANUARY 23, 2021**

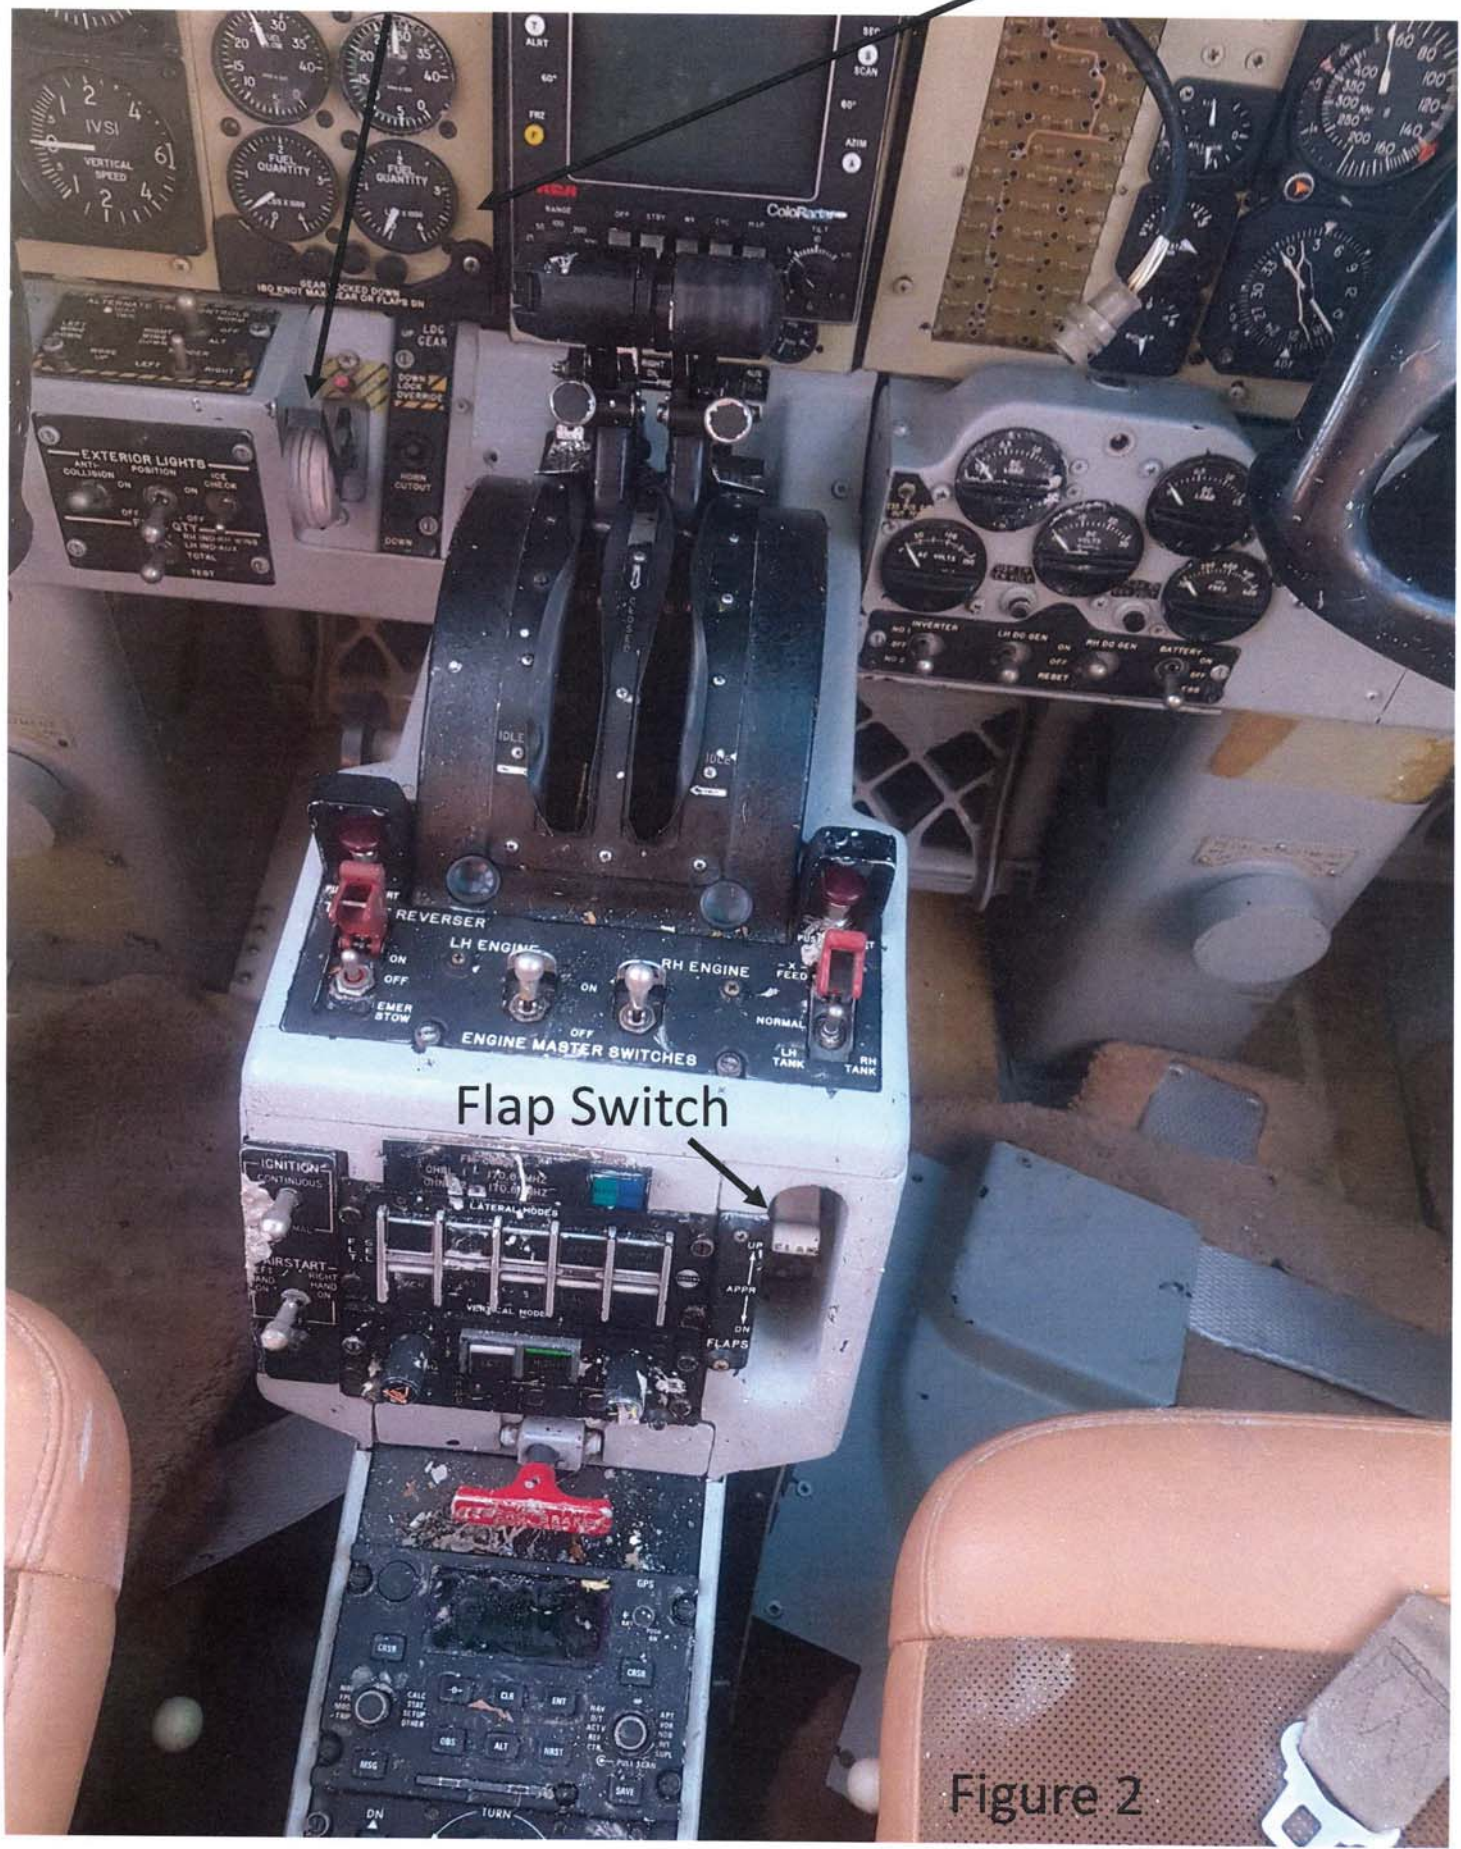
Figure 2

2.3 Aircraft may have made a gear up/flaps up landing (*Fig 2: Cockpit Switches*). Left-wing leading-edge slats were deployed indicating low airspeed and possible high angle of attack at time of impact (*Fig 3: Left Wing*).

6.4 No post-crash fire observed. (Fig. 2).

Landing Gear Switch

Fuel Indicator

Flap Switch

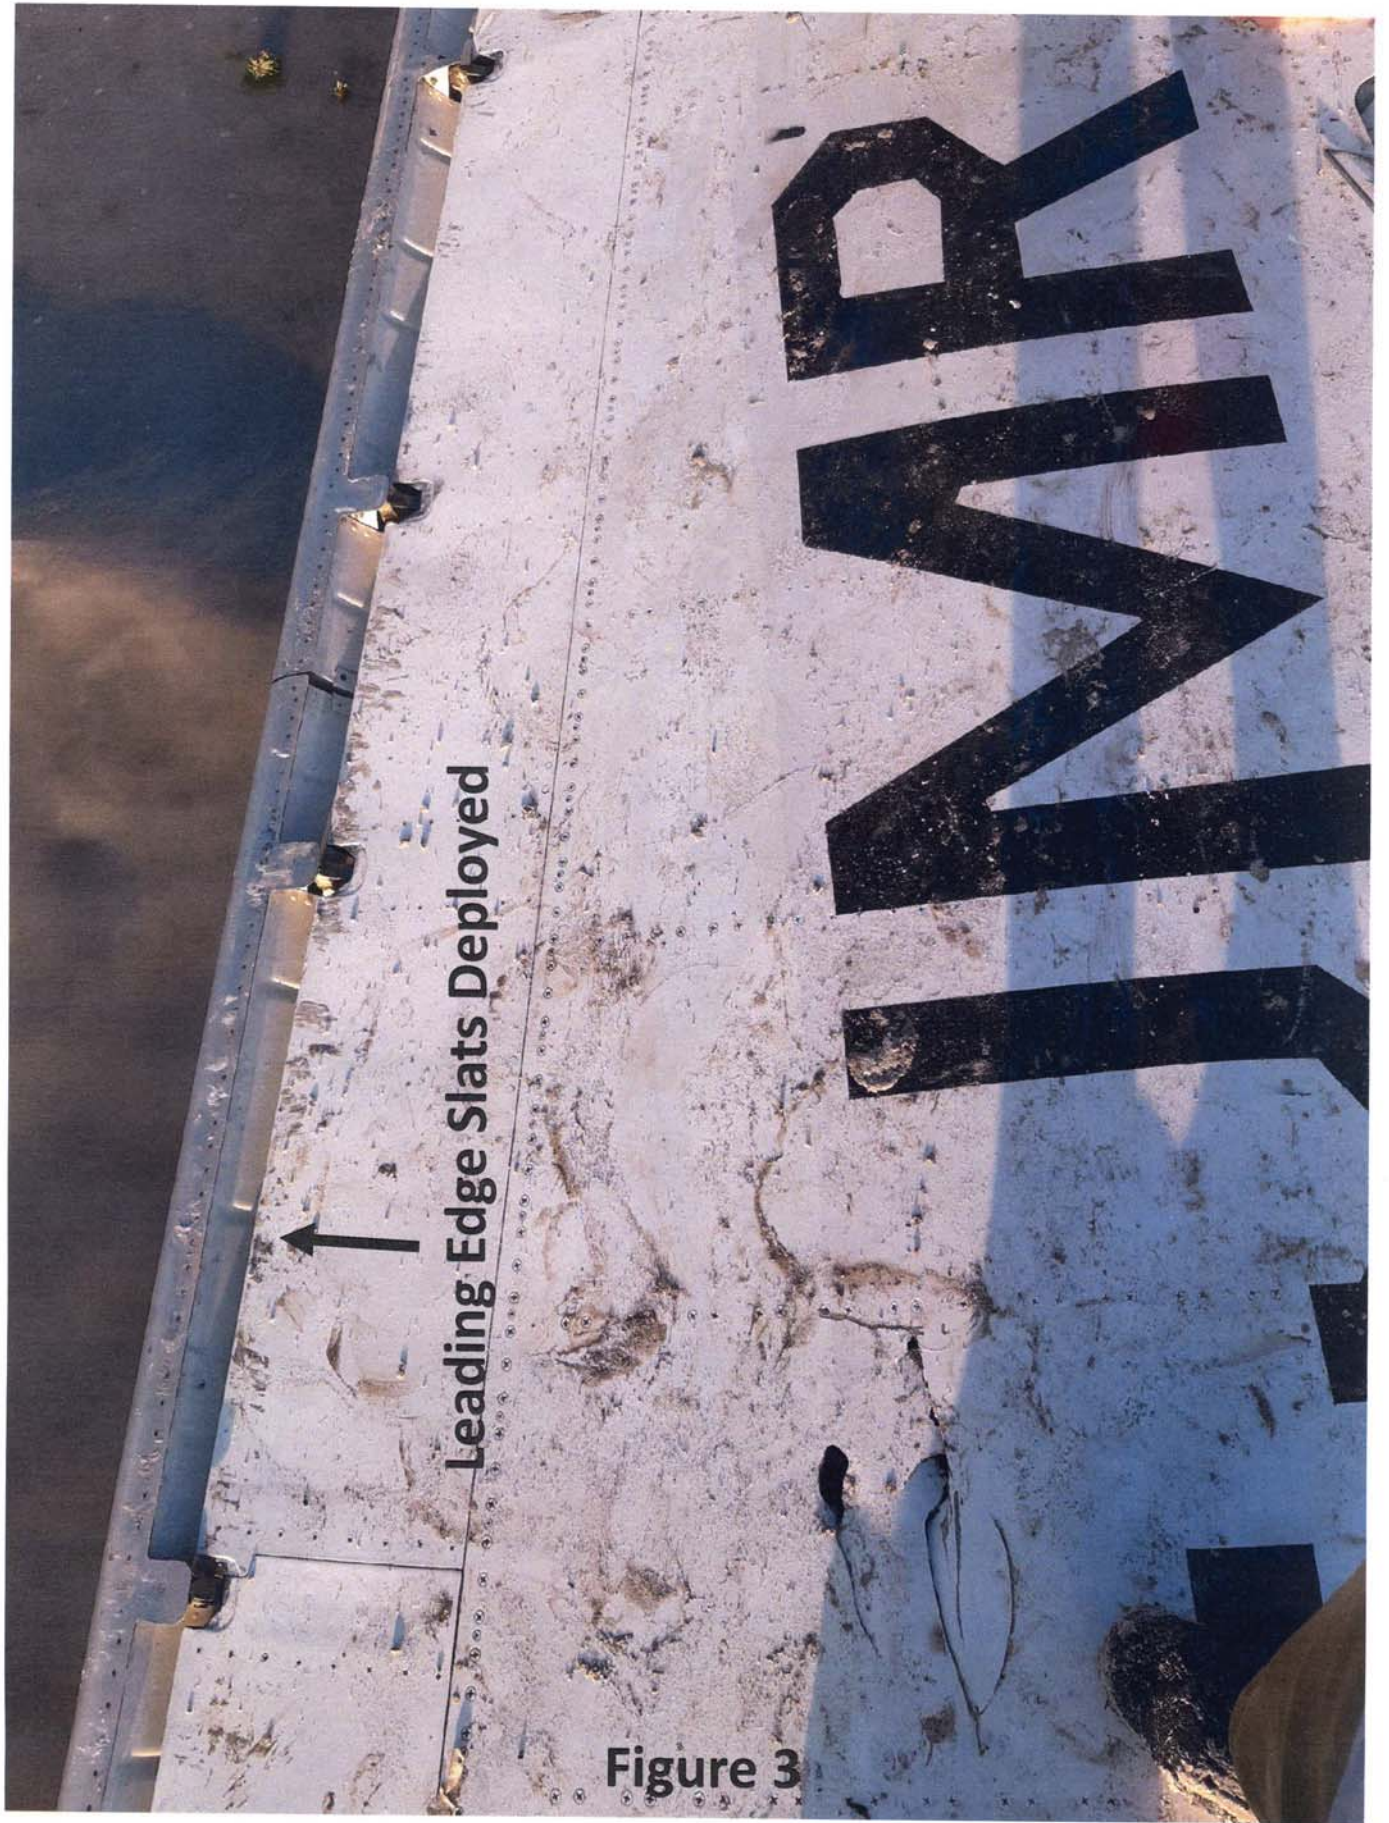
Figure 3

Leading Edge Slats Deployed

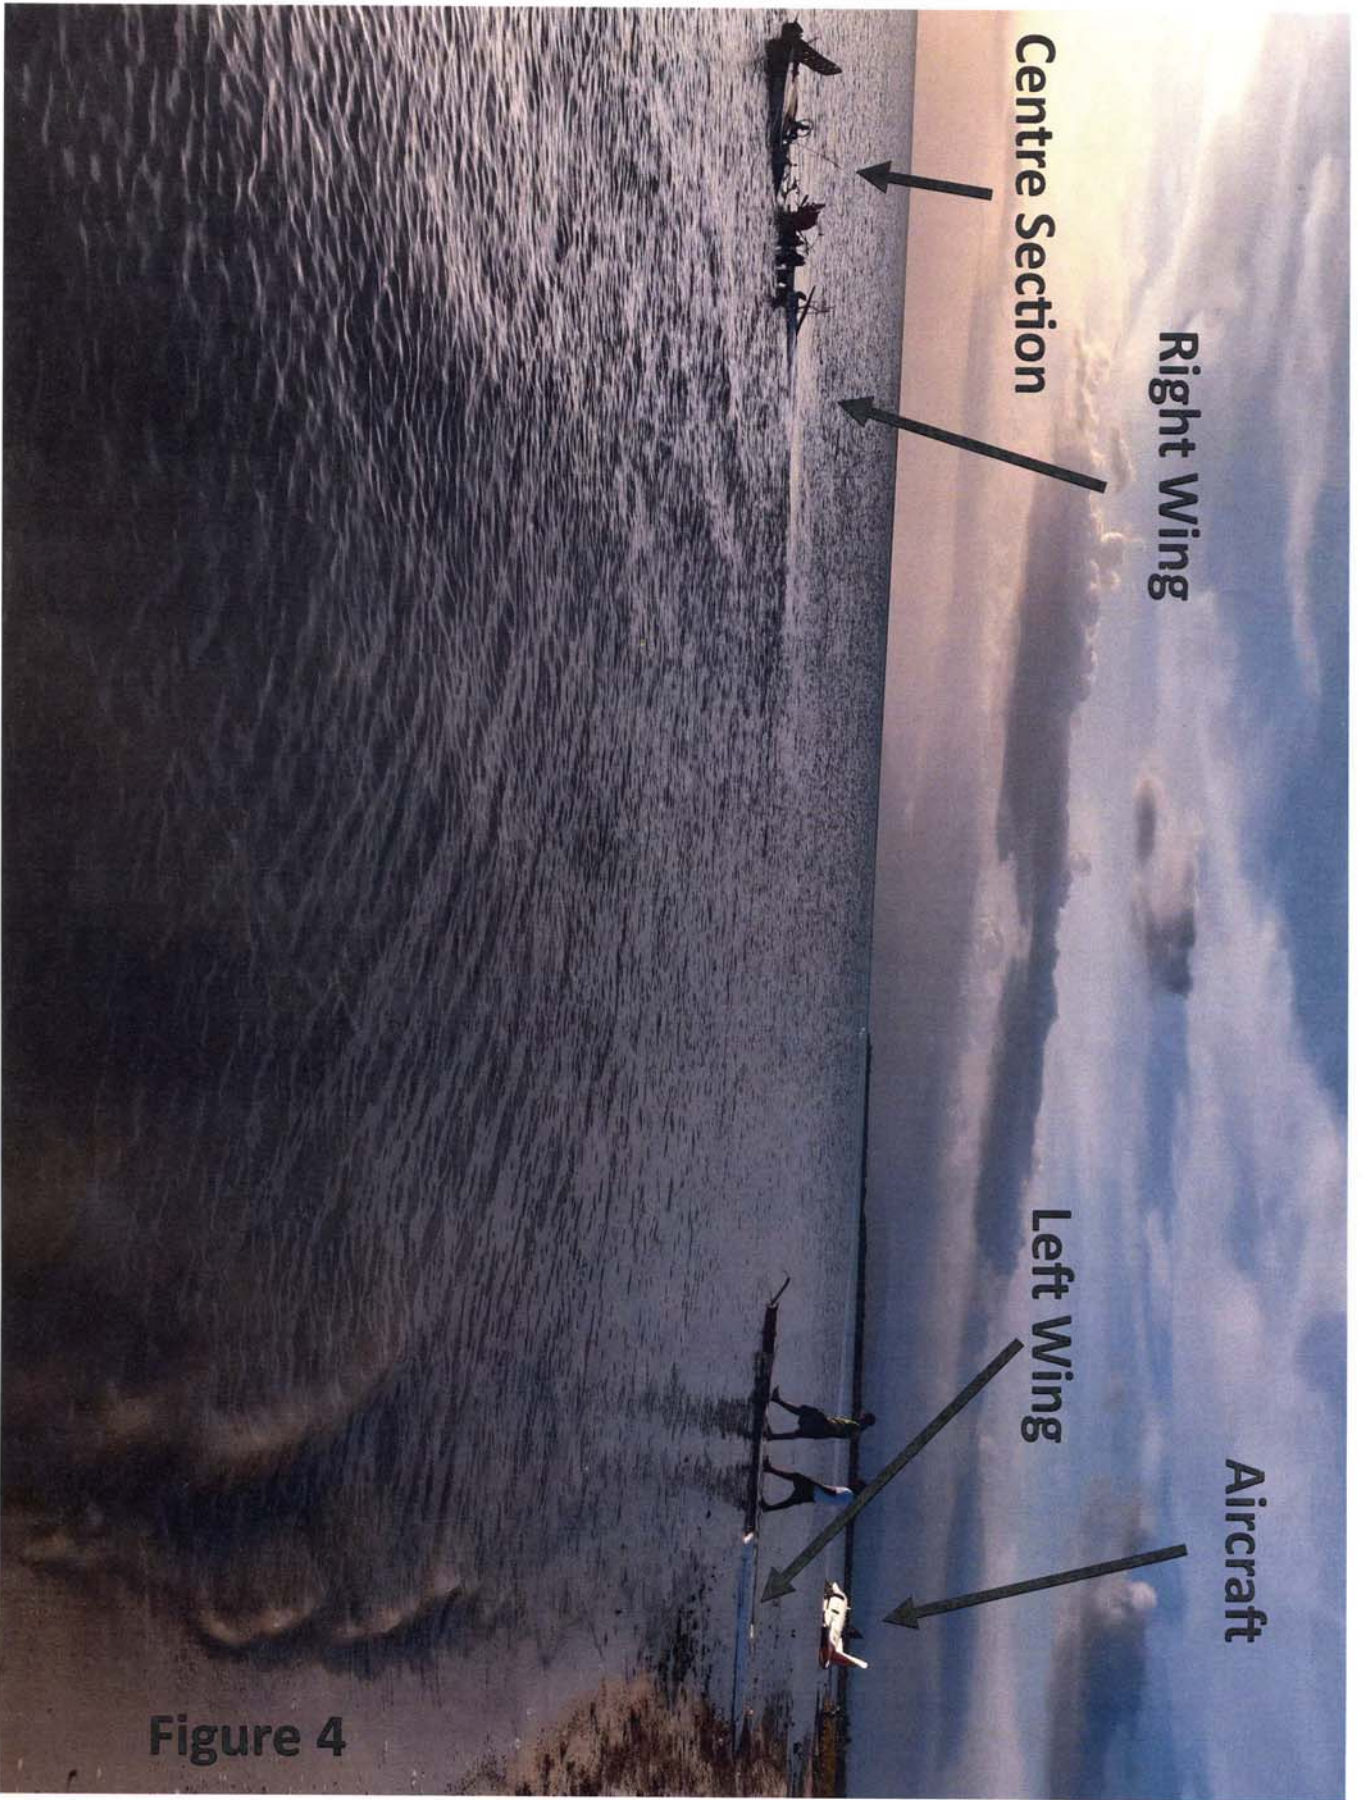
Figure 4

6.2 Substantial Damage: both wings and center section torn from fuselage (Fig. 4- impact damage).

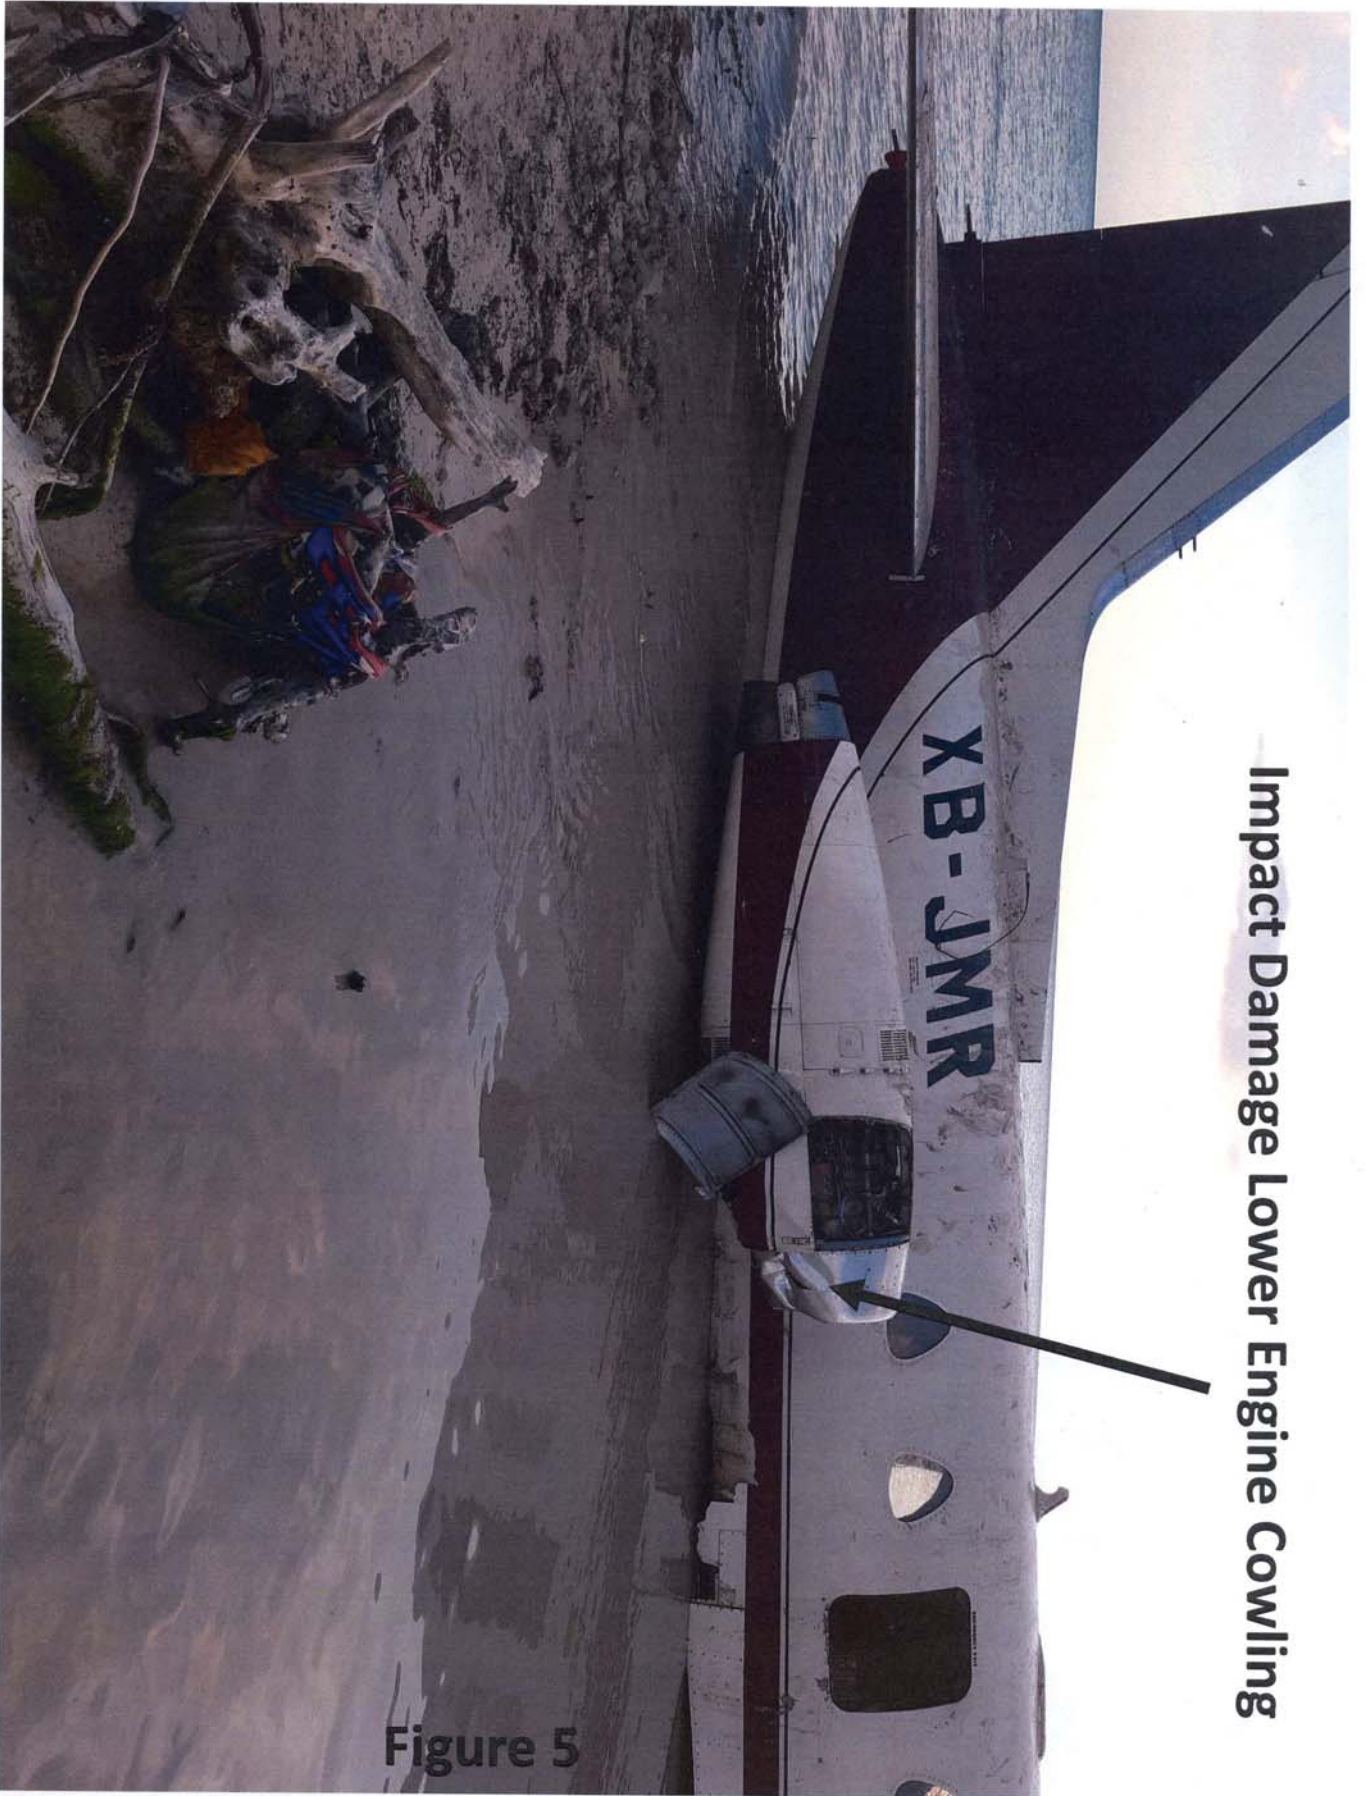
**Figure 5**

6.3 Both engines showing impact damage to lower engine cowling. (Fig 5).

**Impact Damage Lower Engine Cowling**

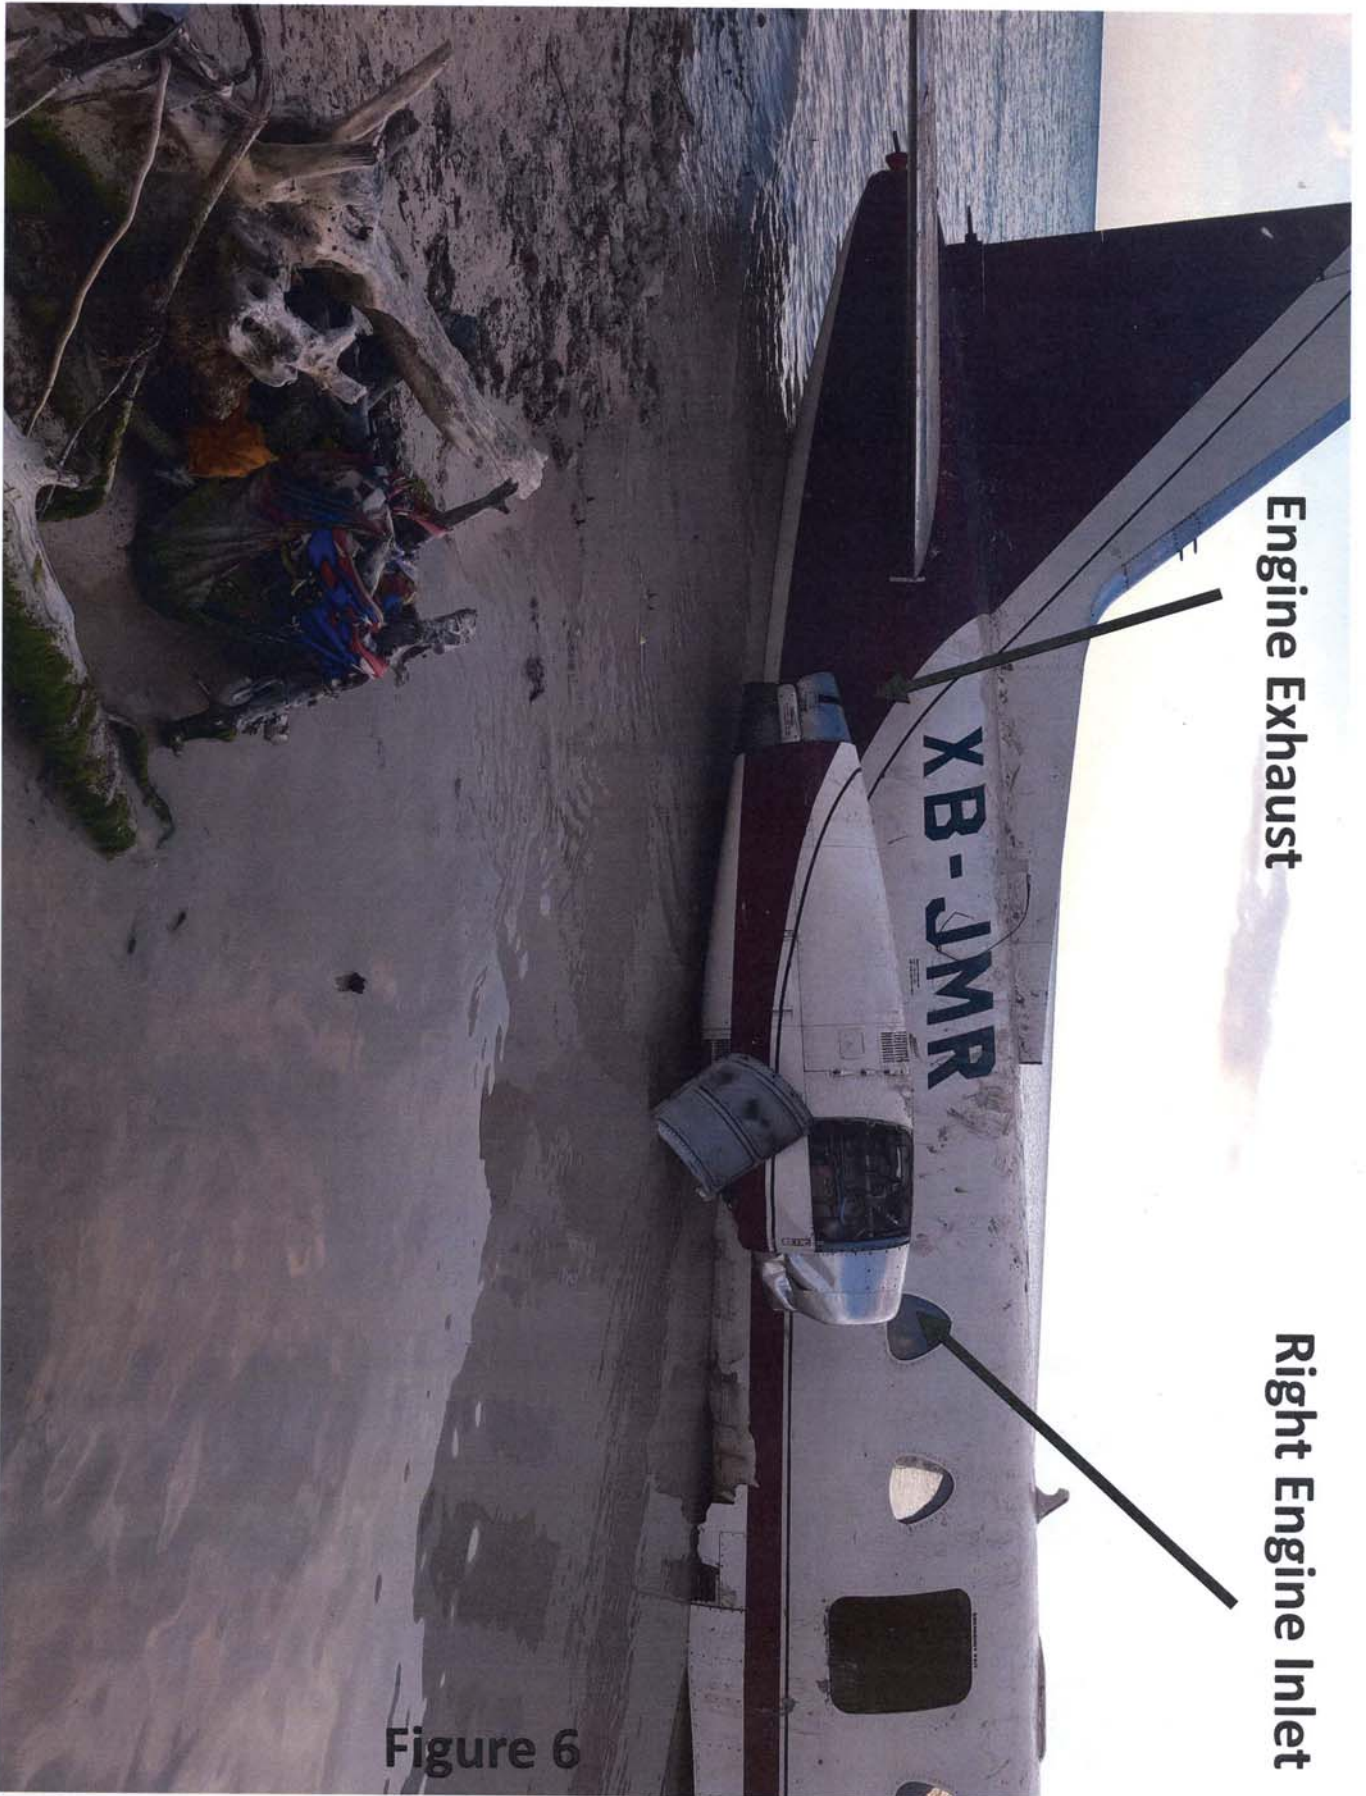
Figure 6

6.5 No signs of fire on both engine exhaust and inlet areas. (Fig. 6 & 6A).

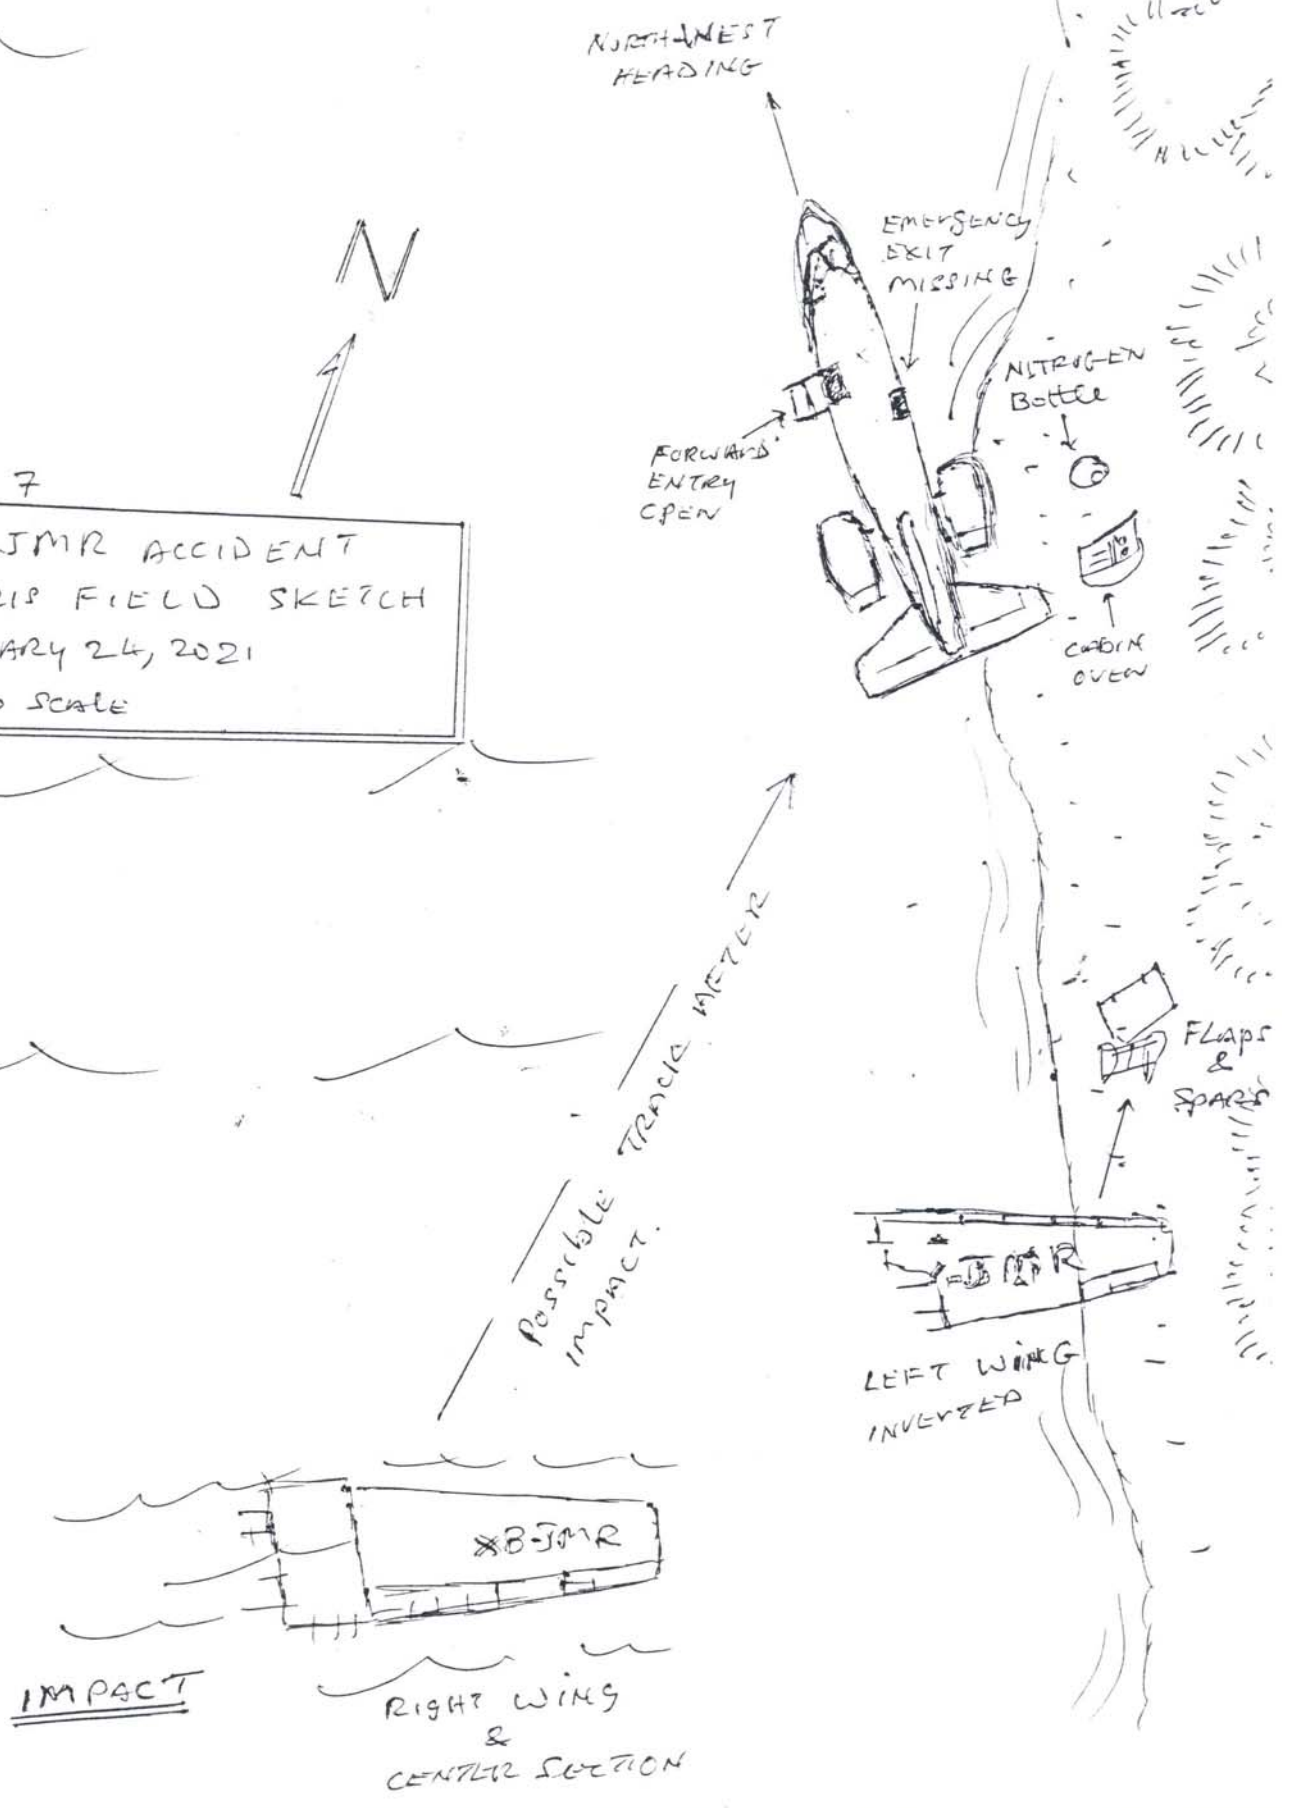
FIG 7  
NOTE: XB-JMR ACCIDENT  
DEBRIS FIELD SKETCH  
JANUARY 24, 2021  
— NOT TO SCALE

6.7 The impact broke the aircraft into three sections. See Debris Field Diagram (Fig.7).

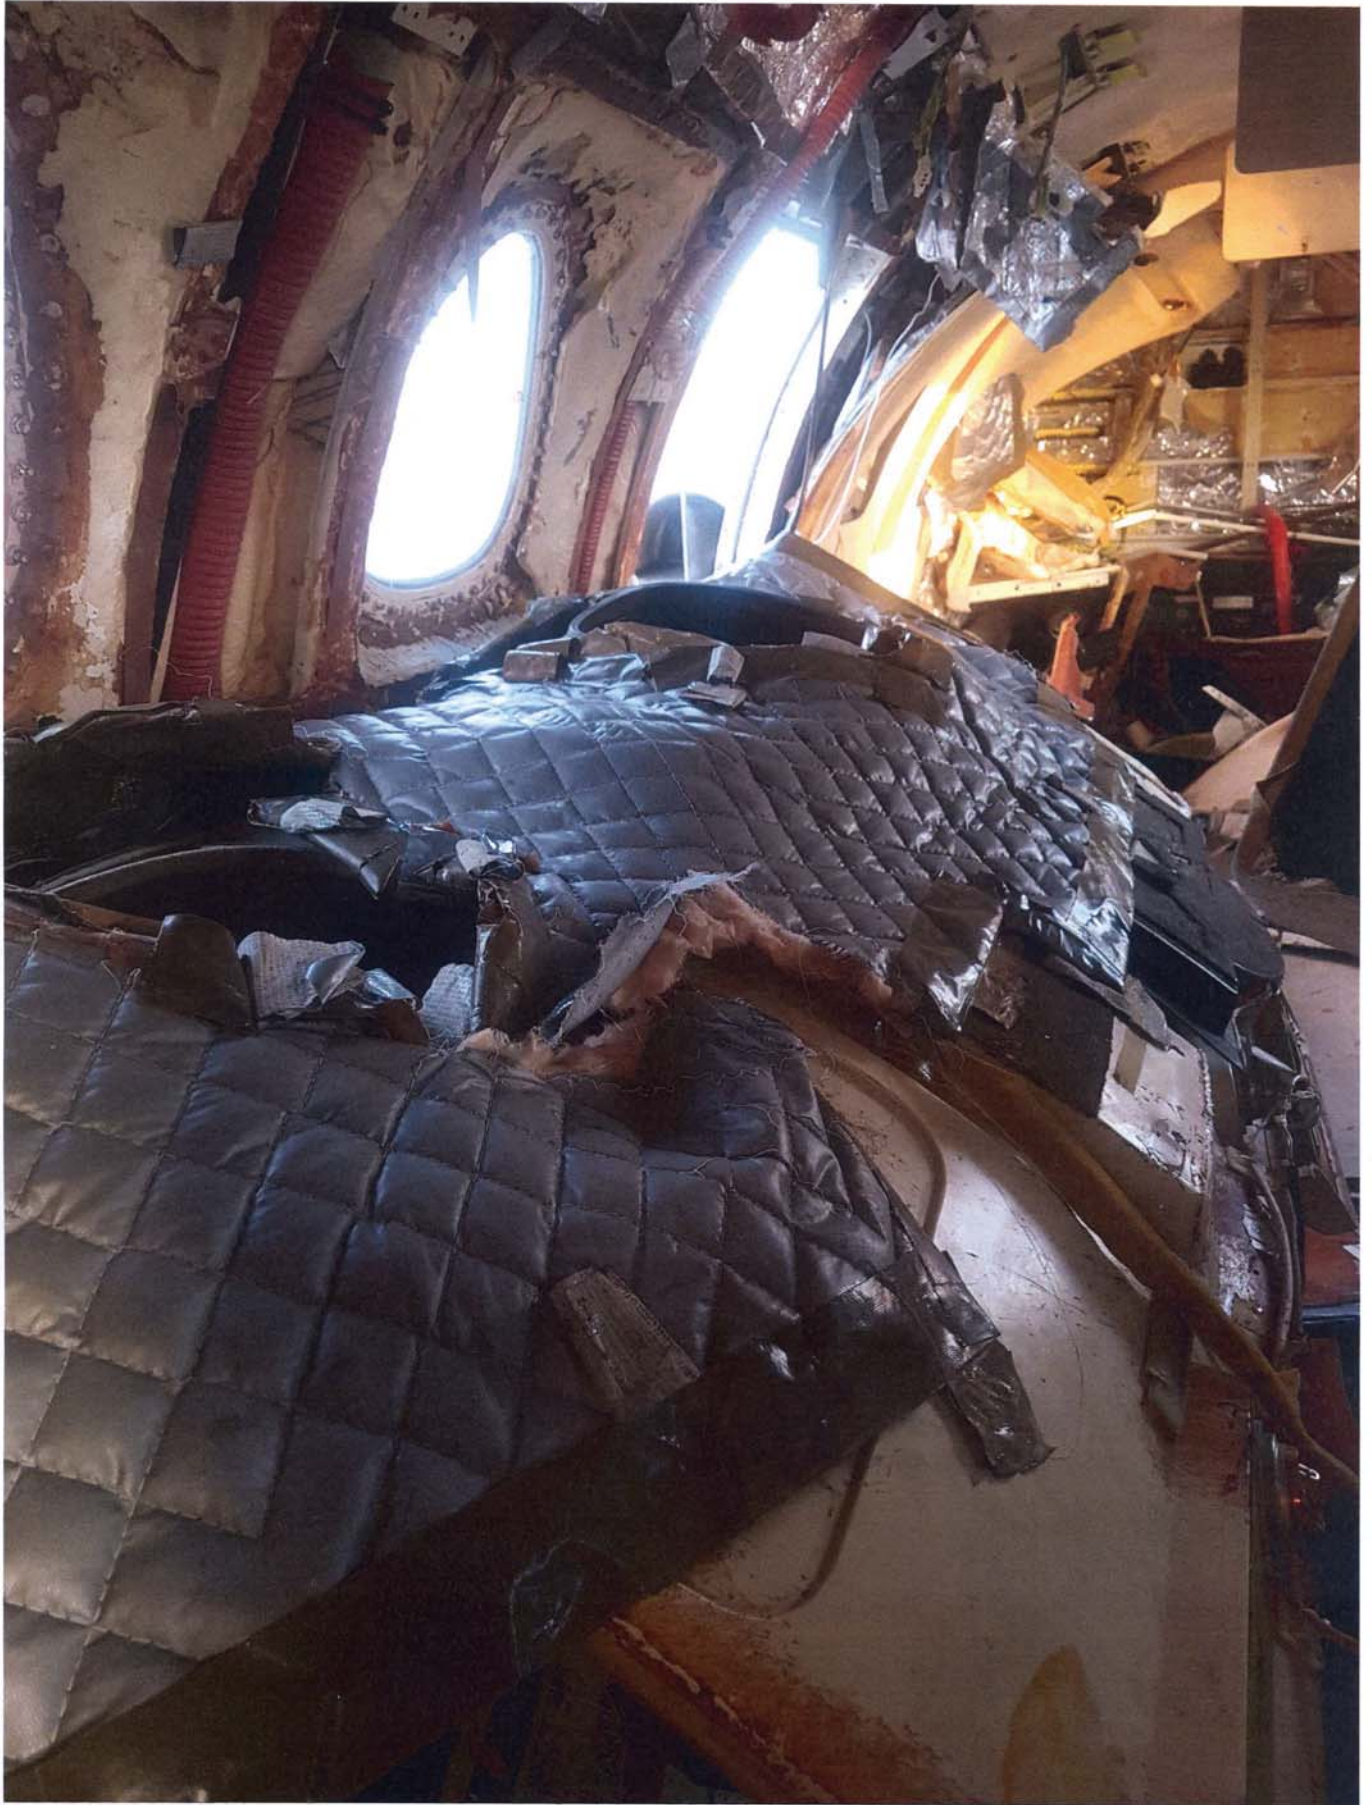
**Figure 8**

6.8 The aircraft cabin had evidence of possible vandalism (Fig. 8).
