AVIATION ACCIDENT REPORT FOR

CESSNA 152

REGISTRATION 6Y-JGA

DRAFT REPORT

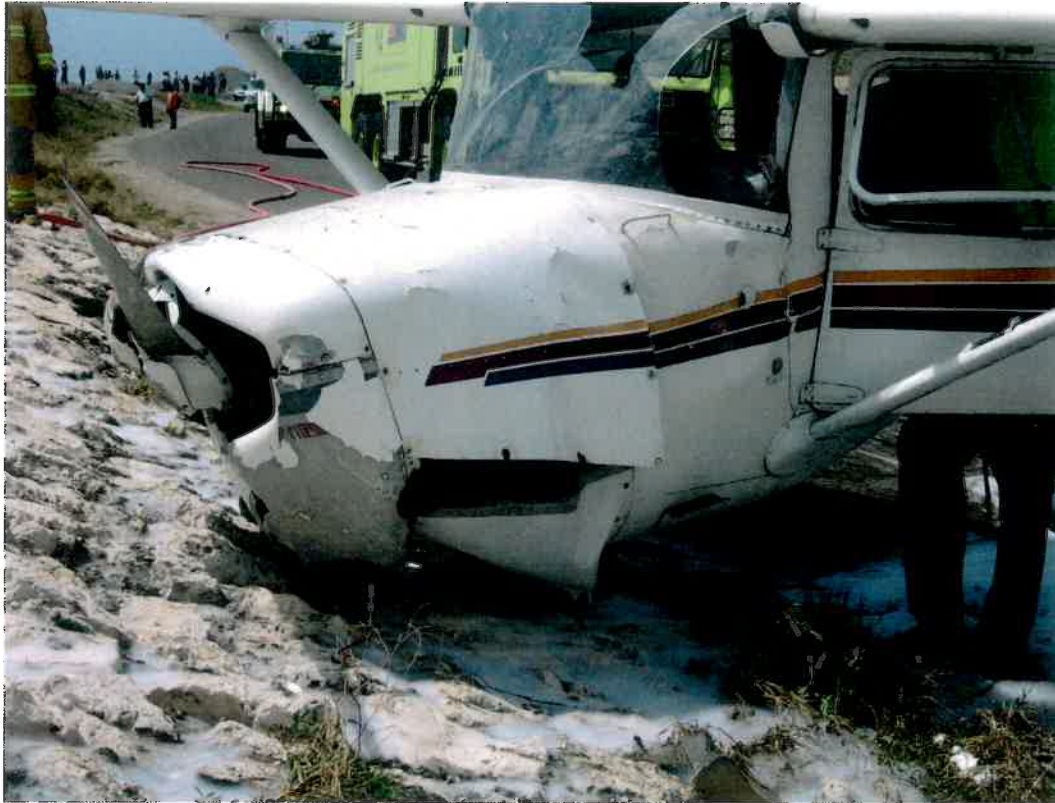
The aircraft sustained major damage to the fuselage nose section. The skin on the aircraft fuselage just aft of the doors showed evidence of wrinkles, and the passenger door had evidence of deformation. The right wing tip sustained impact damage at the leading edge. The windshield was shattered and the compass broke loose and was thrown forward of the aircraft. The nose landing gear snapped at the attachment point.

One propeller blade was bent back onto the lower right side of the engine and the other blade was undamaged. The damage to the propeller was consistent with it turning at impact.

The entire engine shifted aft into the firewall. The crankshaft flange for the attachment of the propeller was bent and the generator was damaged. The carburetor body was broken off at the neck which resulted in all the fuel draining from the aircraft.

Photo 1. Major damage to fuselage nose section, nose landing gear and propeller

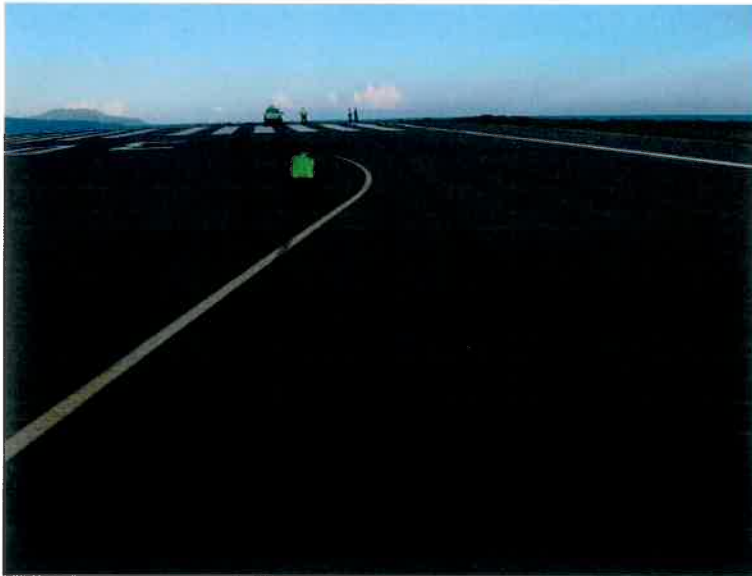
There were tire skid marks for the last three hundred and sixty (360) feet of runway 12. Both main wheel tires exhibited flat spots. Just prior to the aircraft exiting the end of runway, the right main gear struck a threshold light assembly which resulted in the light being broken and destroyed. The propeller hit the chain link fence, and the right wing tip came in contact with one of the vertical fence posts, which resulted in damage to the right wing tip leading edge.

Photo 2. Main wheel tire skid marks, which continued to the end of the runway.

The evidence indicated that the pre-accident condition of both tires was fairly new. The flat spots found on both main tires and the continuous skid marks on the runway indicated that the brakes were fully functional and were applied heavily during the last 360 feet of the landing roll.

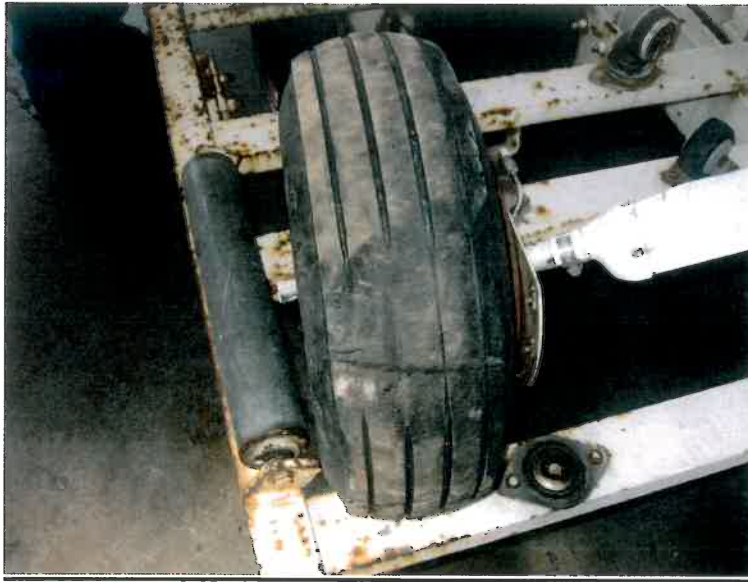
Photo 3. Left main gear tire flat spot.

- e) The brakes were inspected and found to be in satisfactory condition.
- f) Both main landing gear tires appeared to be nearly new, had good tread on them, and each one had a significant flat spot on it.

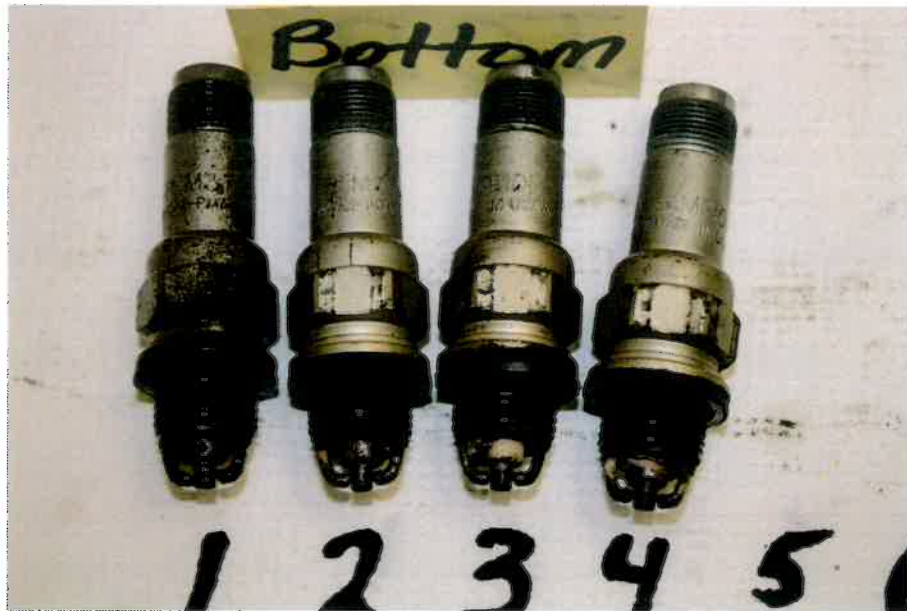
- o) On all cylinders the top plugs were free of any contamination and the lower plugs had some lead build-up.
- p) Insulation checks done on the spark plug leads were all satisfactory.

The lower spark plugs were found to have large accumulations of lead deposits. According to Lycoming's summary report, this "could result in a few hundred RPM loss at take-off power setting". When tested, each of these plugs did produce a spark, but not with the intensity of an almost new plug.

Lower plugs installed in each cylinder
