AIRCRAFT ACCIDENT REPORT

| AIRCRAFT | CESSNA 172 |
| REGISTRATION | 6Y-JGT |
| DATE & TIME OF ACCIDENT | MAY 30, 1996 AT 0709 HRS. LOCAL |

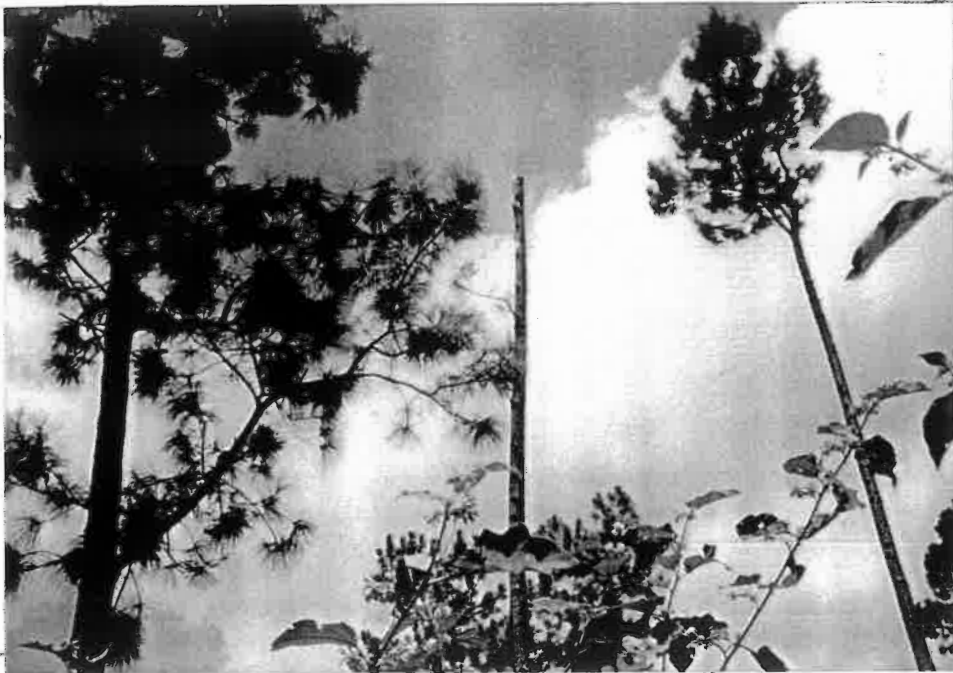
- 2.8.3 Leaving Gordon Town, the aircraft entered at a valley - "Content Gap" between two ranges of the Blue Mountains. While the student pilot was concerned with clearing the valley the starboard wing inadvertently struck at a pine tree about 50 feet above the earth severing the top of the tree from the trunk. The aircraft received substantial damage to that wing and commenced an uncontrolled descent.

Pine Tree struck by leading edge of starboard Wing

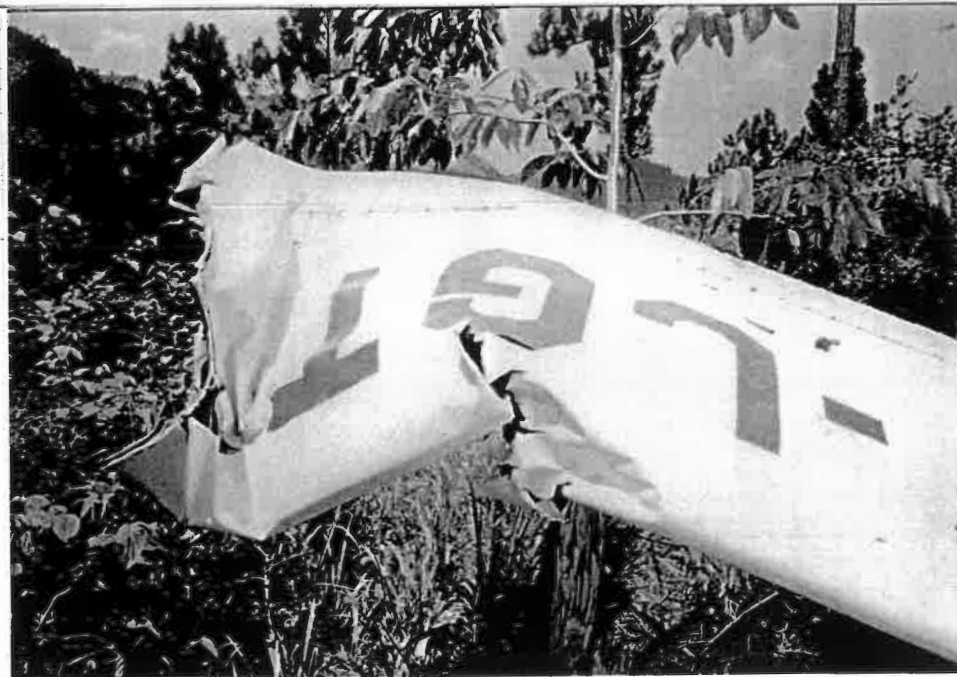
- 2.9.1 The starboard wing was broken and severed from the fuselage.
- 2.9.2 The port wing was damage and fuel was leaking from that wing. The under carriage was completely broken off, the engine was broken off from its mounting and the propeller blades were bent, the tail planes were twisted and bent.
- 2.9.3 The student pilot was not injured and she left the aircraft and joined a number of men all employees of the estate. They were advised not to go near the aircraft as fuel was leaking from the port wing tank.
- 2.9.4 The student pilot was escorted to the estate office and taken to the University Hospital.

Starboard Wing leading edge broken by impact with Pine Tree and severed from the fuselage.

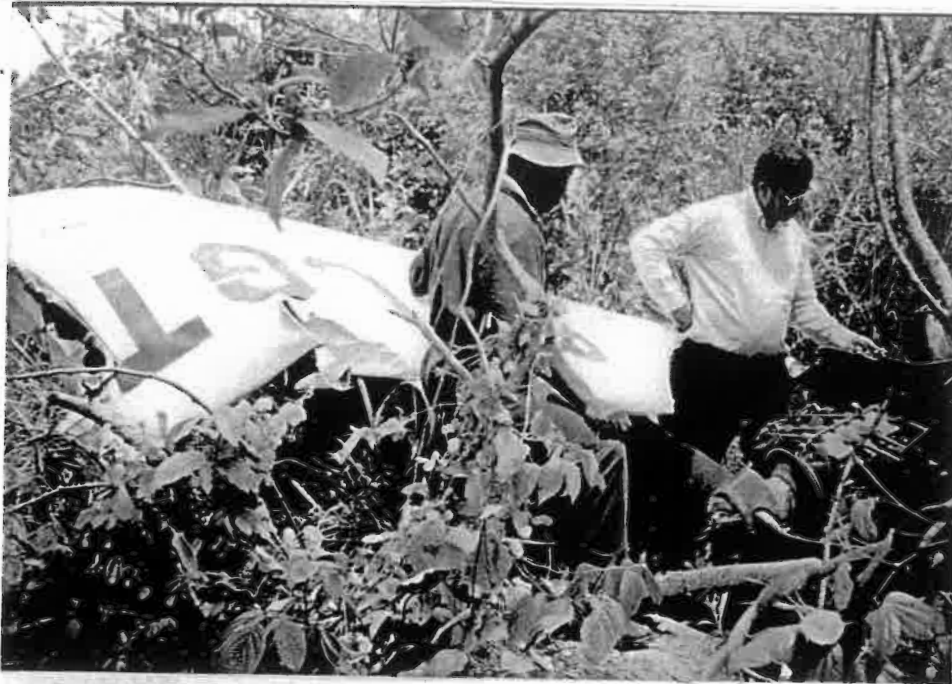
Engine moved forward from its mounting and both blades bent backwards.

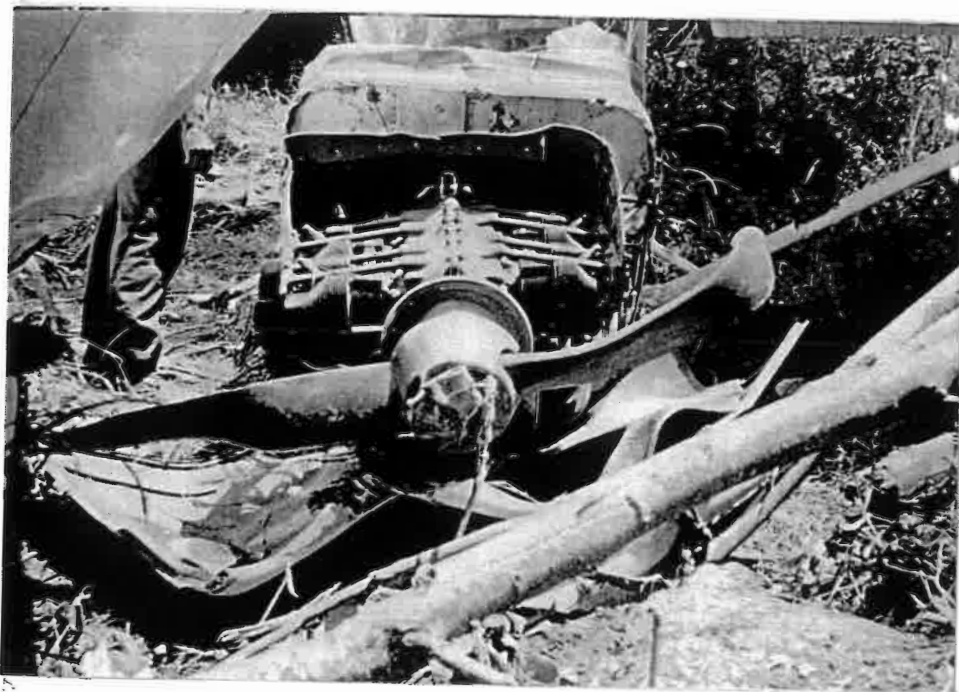
Closer inspection of Engine.

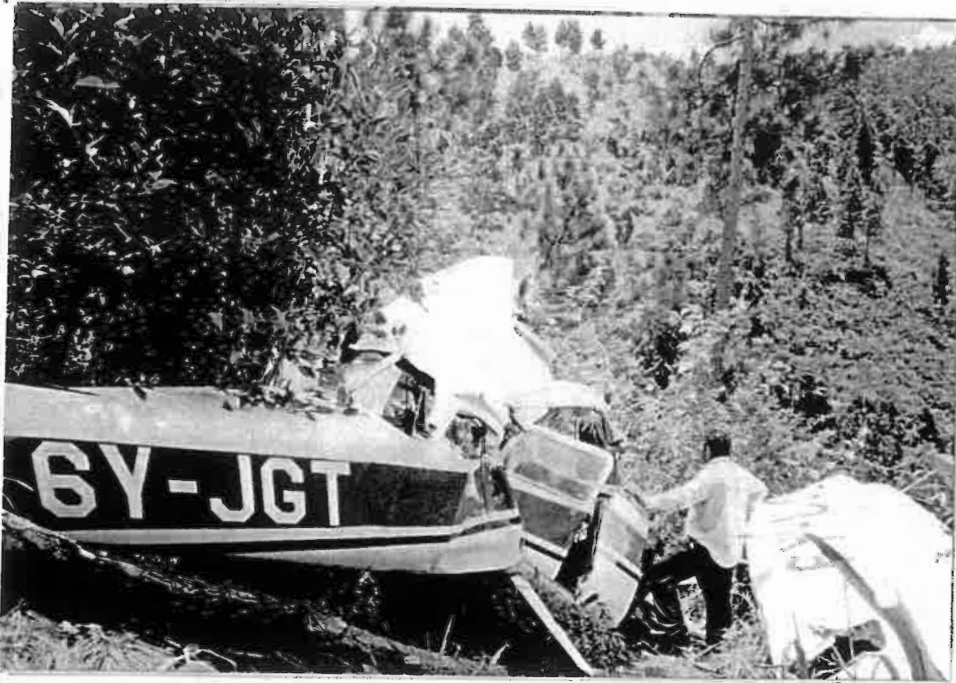
Port wing attached to fuselage and leading edge bent by impact with trees.

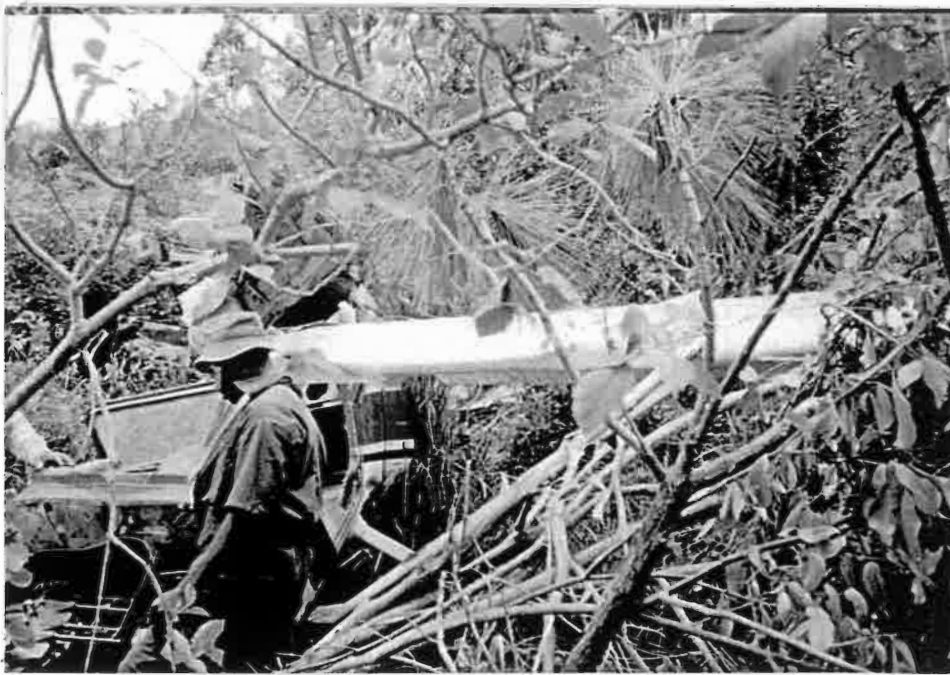
Density of young trees.
