## *Jamaica Civil Aviation Authority*

### **Aviation Occurrence Report Number JA-2024 -01**

AVIATION OCCURRENCE REPORT

**BRAES RIVER – ST. ELIZABETH**  
**AIRCRAFT OF UNKNOWN TYPE – NO IDENTIFIABLE REGISTRATION**  
**JANUARY 6, 2024**

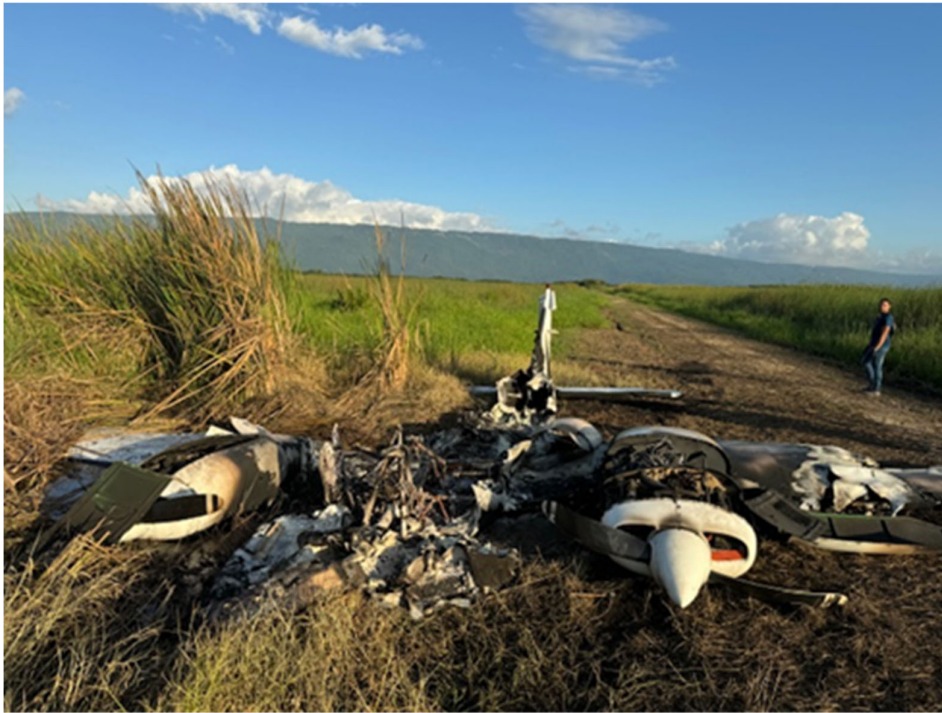
Figure 2 Aircraft Wreckage

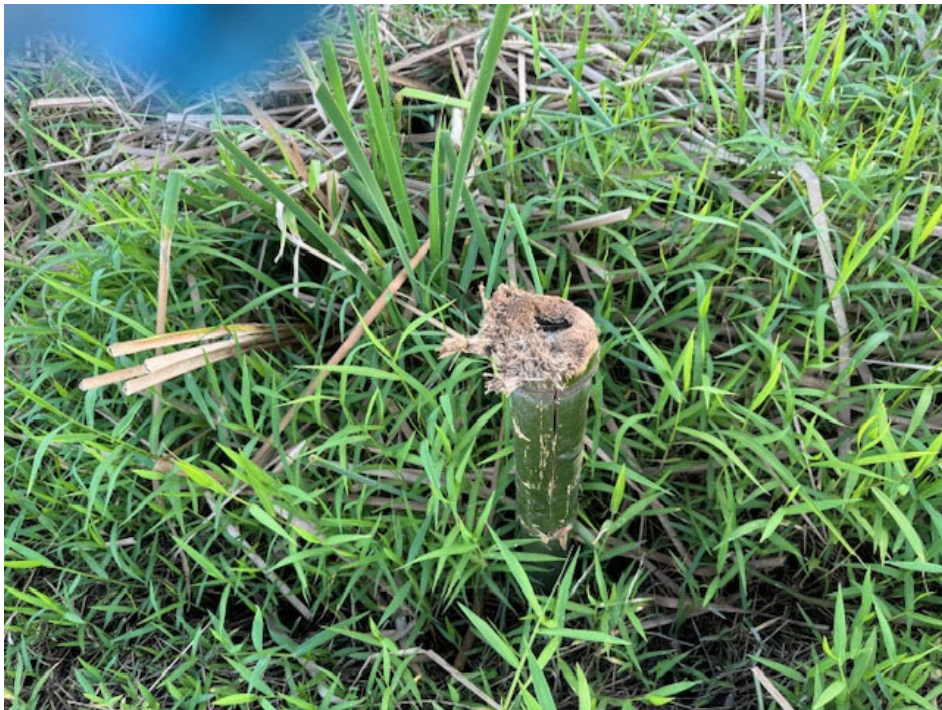
5.2 It is lined by vertical bamboo poles, which houses lighting fixtures.

Figure 3 Bamboo light posts

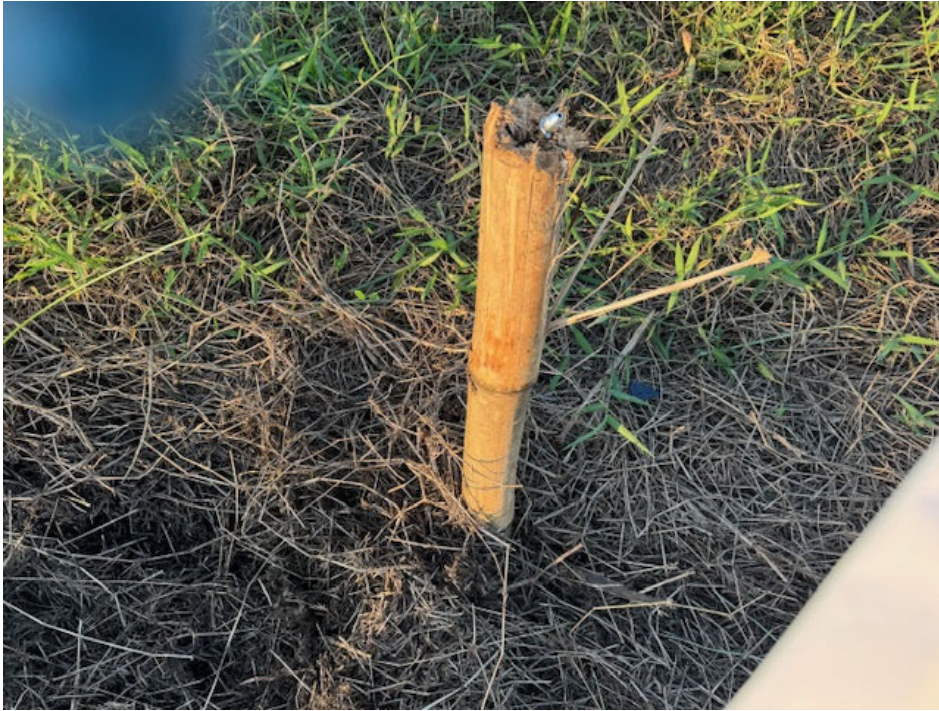
Figure 4 Bamboo light posts

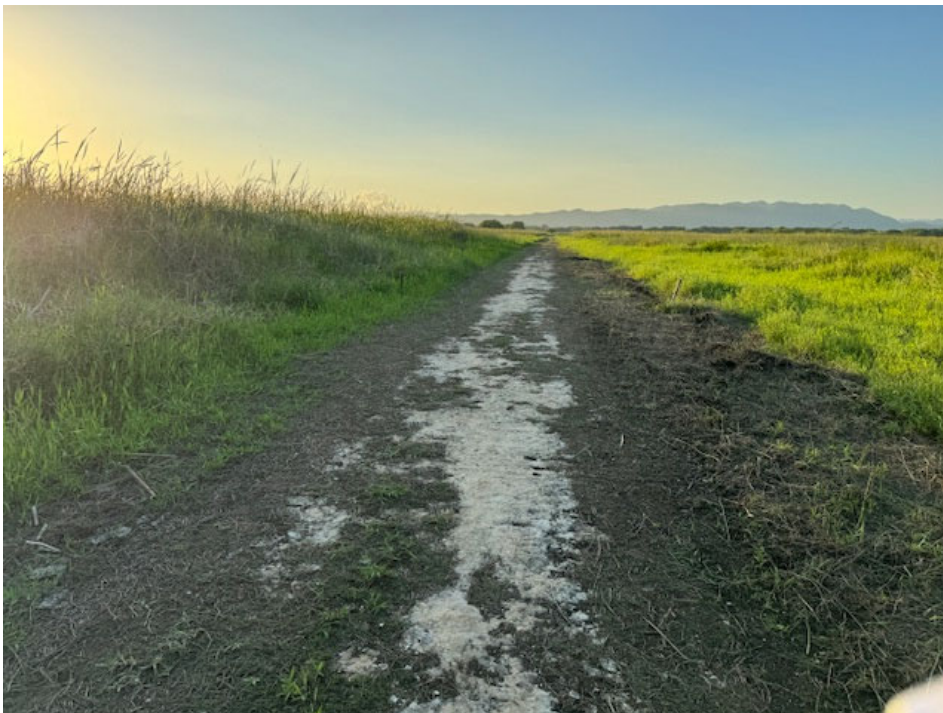
5.1 The landing strip is of flat rock and grass base and greater than 5000 feet in length and approximately 30 feet wide and is unregulated.

Figure 5 unregulated airstrip

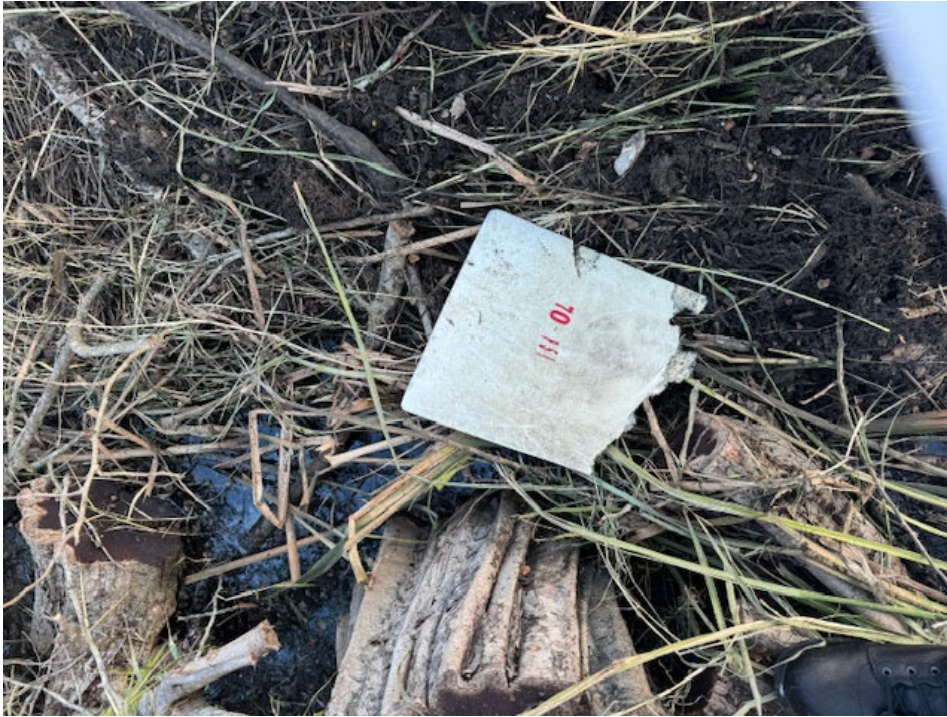
Figure 6 Partially Identifiable wreckage of aircraft

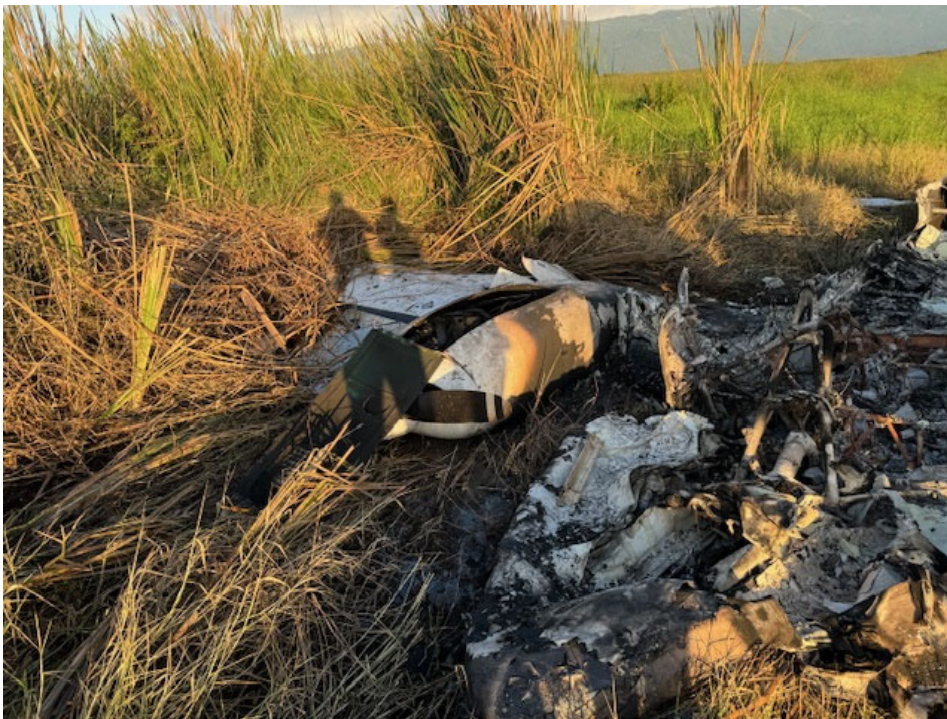
Figure 7 Wreckage of aircraft

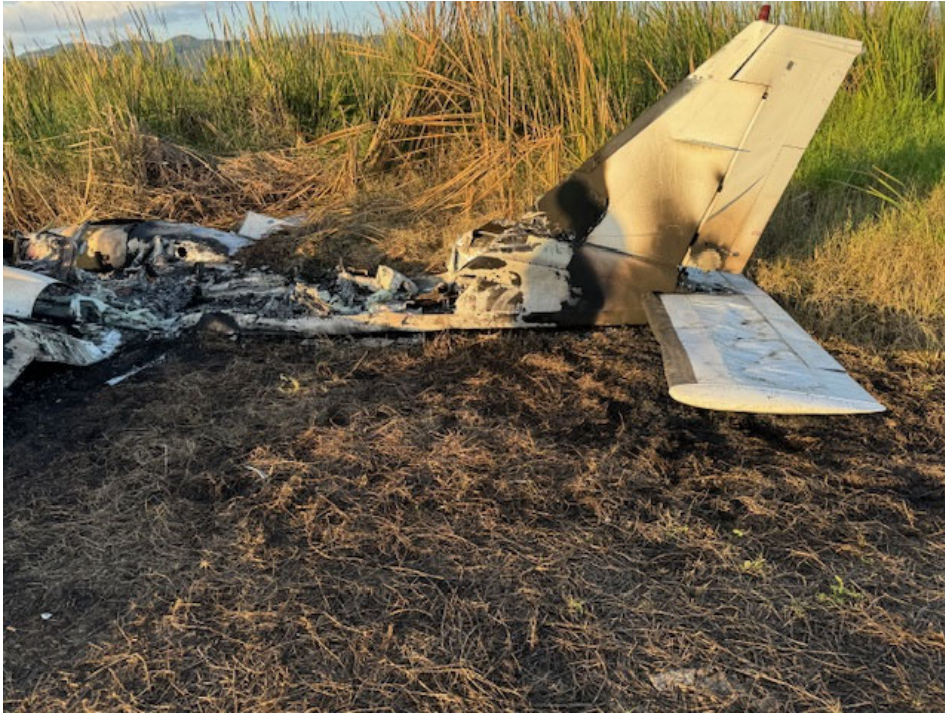
Figure 8 Wreckage of aircraft

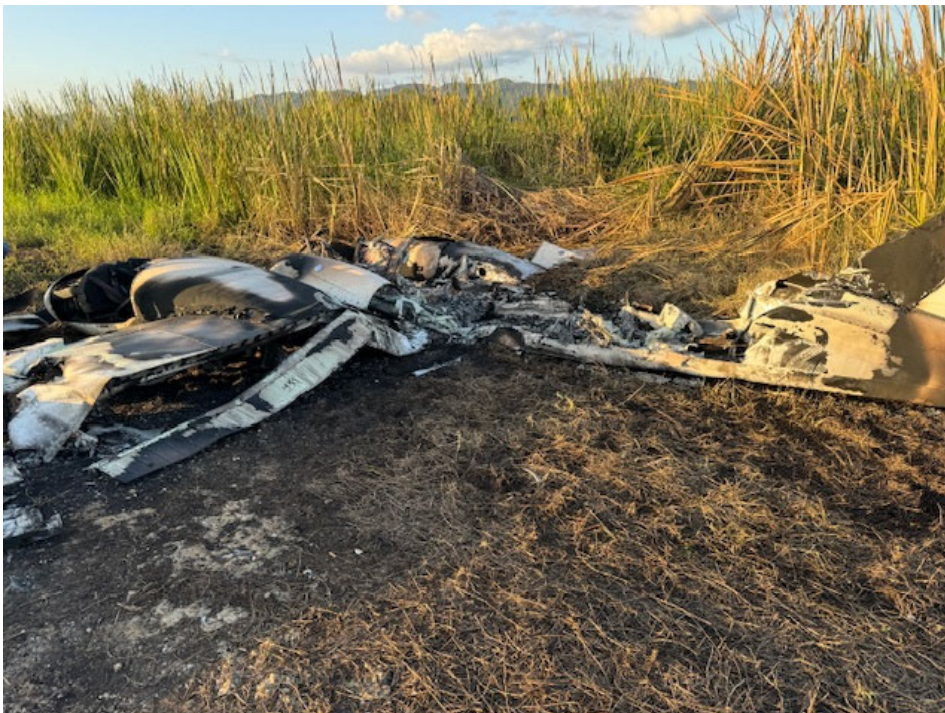
Figure 9 Wreckage of aircraft

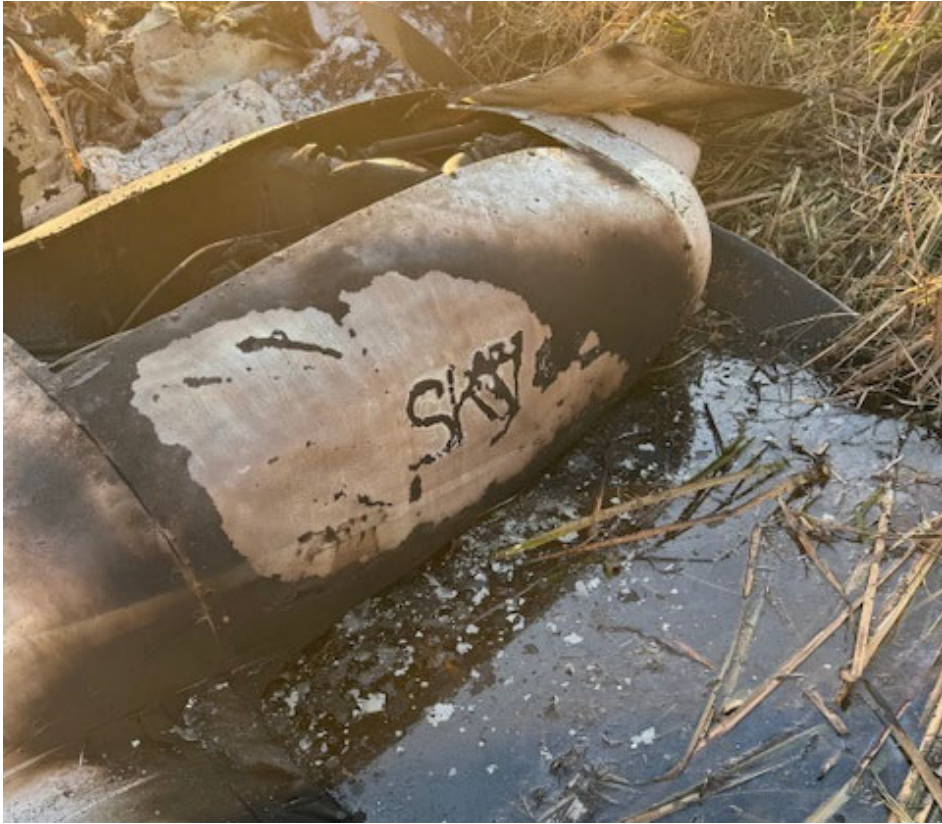
Figure 10 Wreckage of aircraft

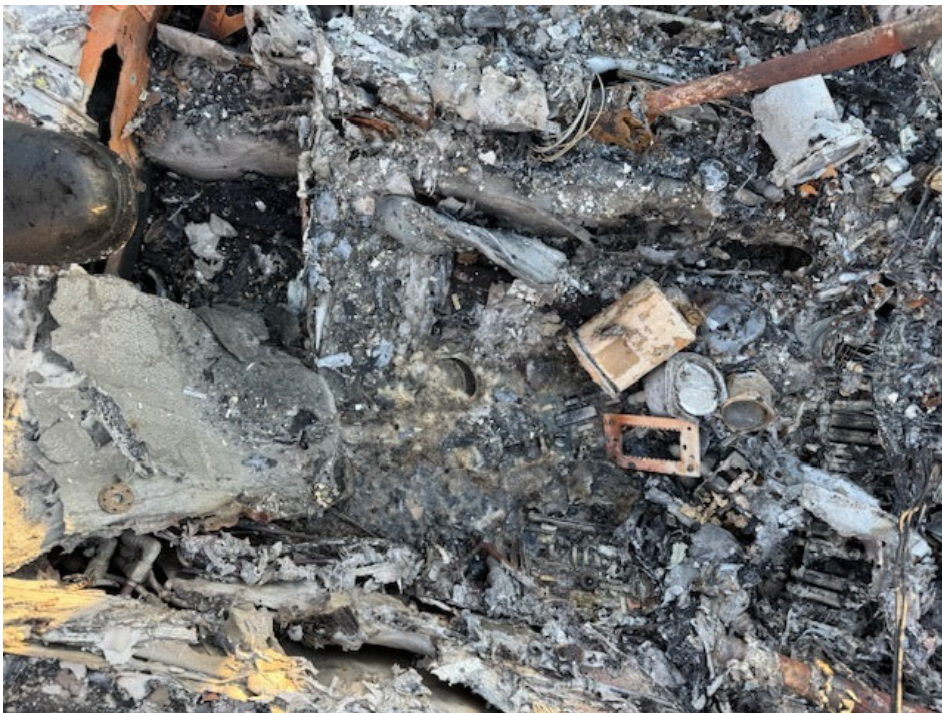
Figure 11 Wreckage of aircraft

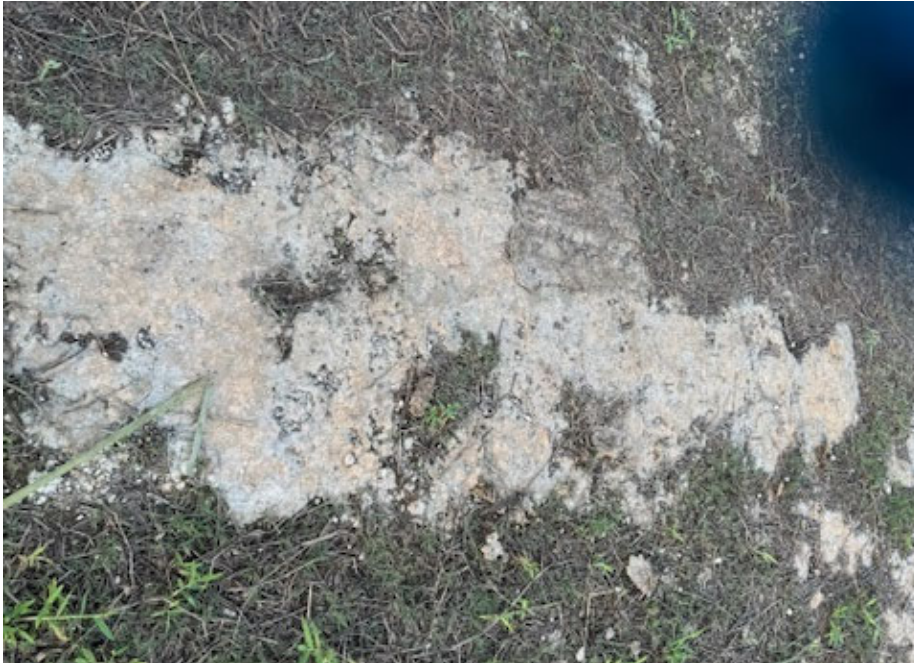
Figure 12 Tyre marks on unregulated runway strip

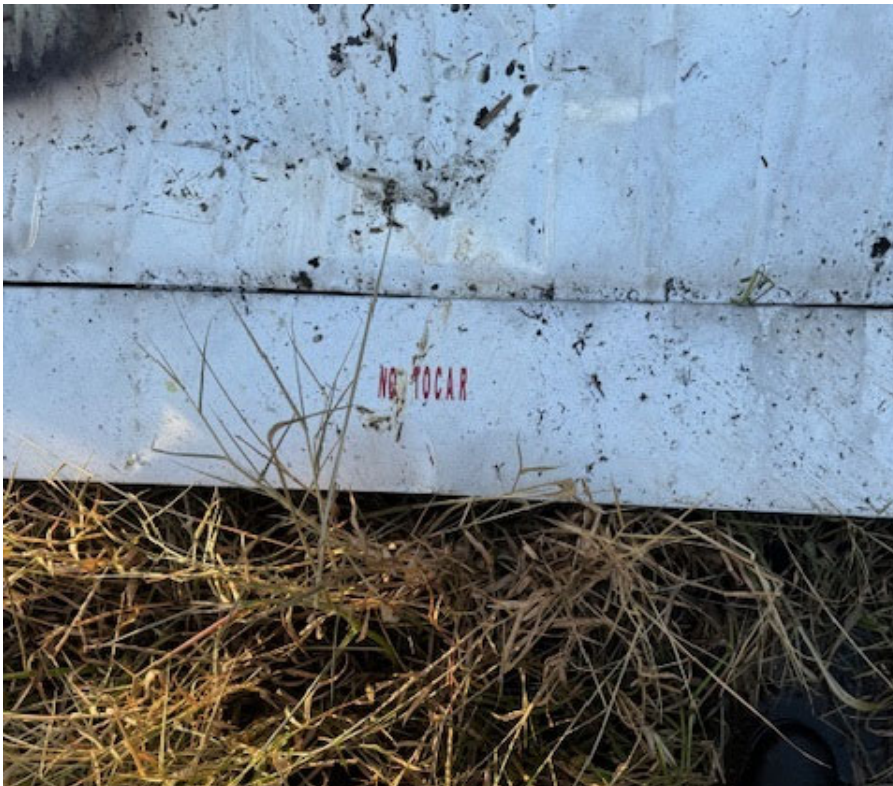
Figure 13 Partially Identifiable wreckage of aircraft

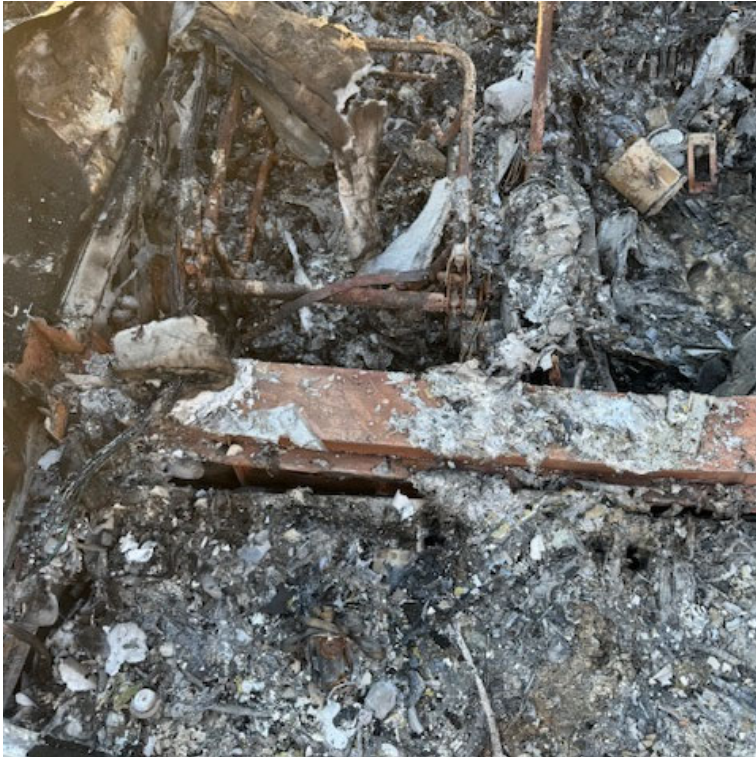
Figure 14 Wreckage of aircraft

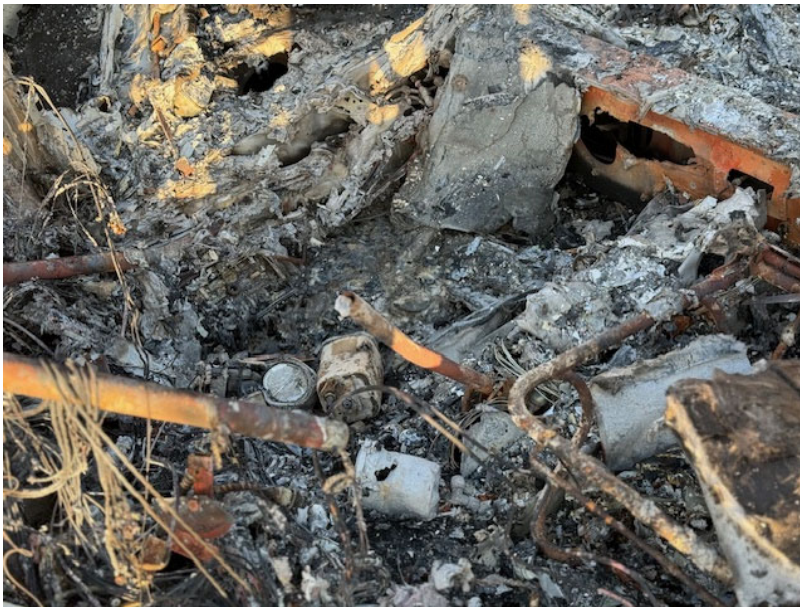
Figure 15 Wreckage of aircraft

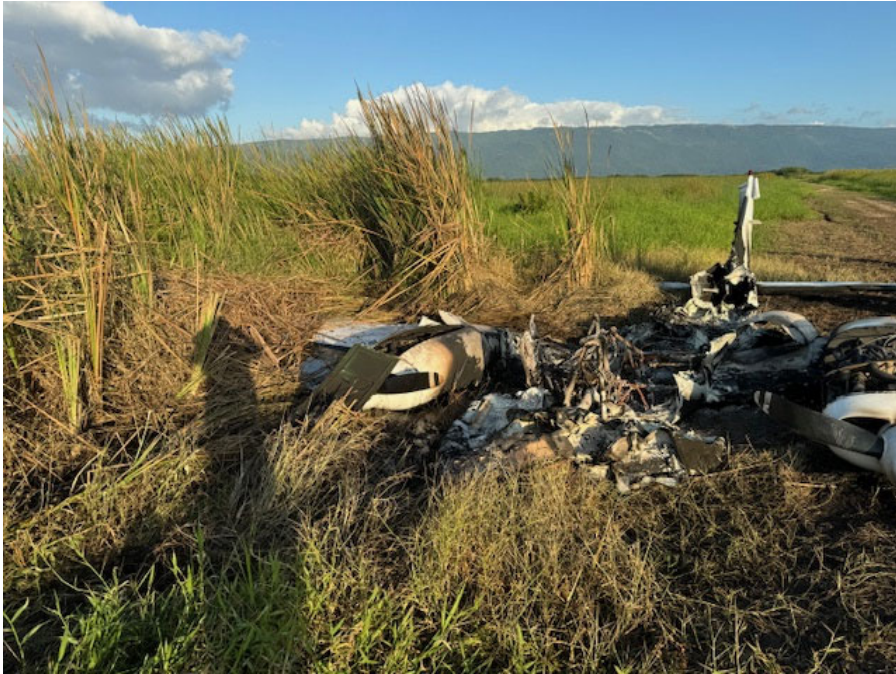
Figure 16 Wreckage of aircraft

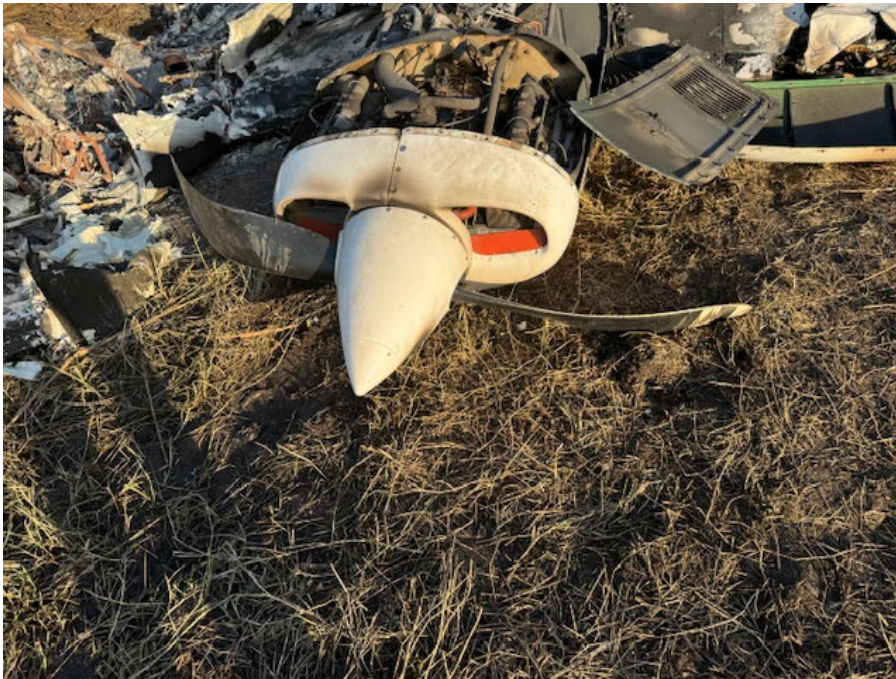
Figure 17 Wreckage of aircraft

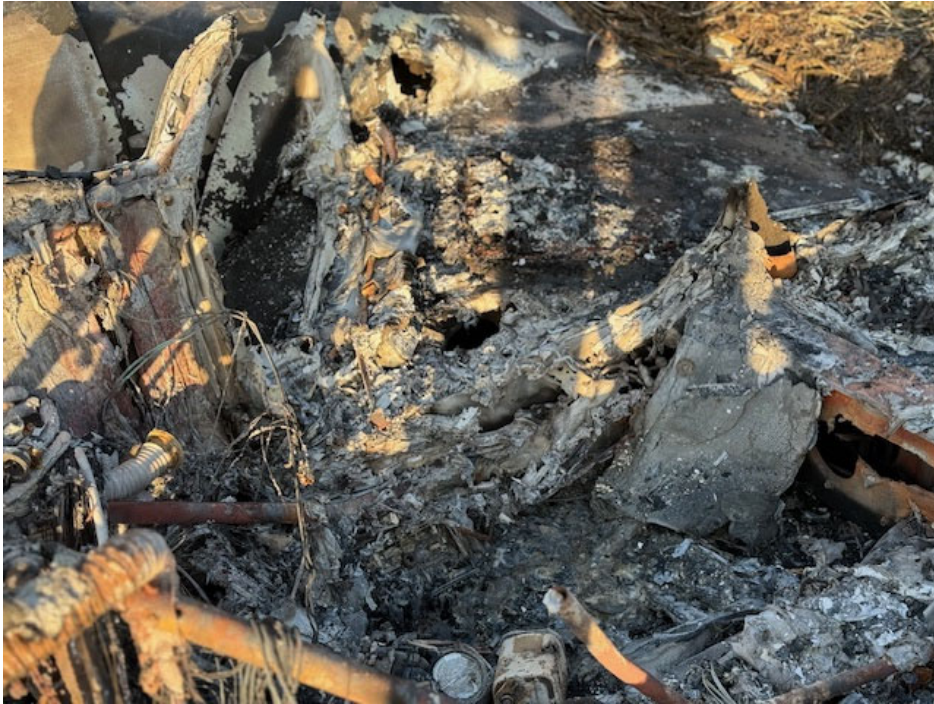
Figure 18 Wreckage of aircraft

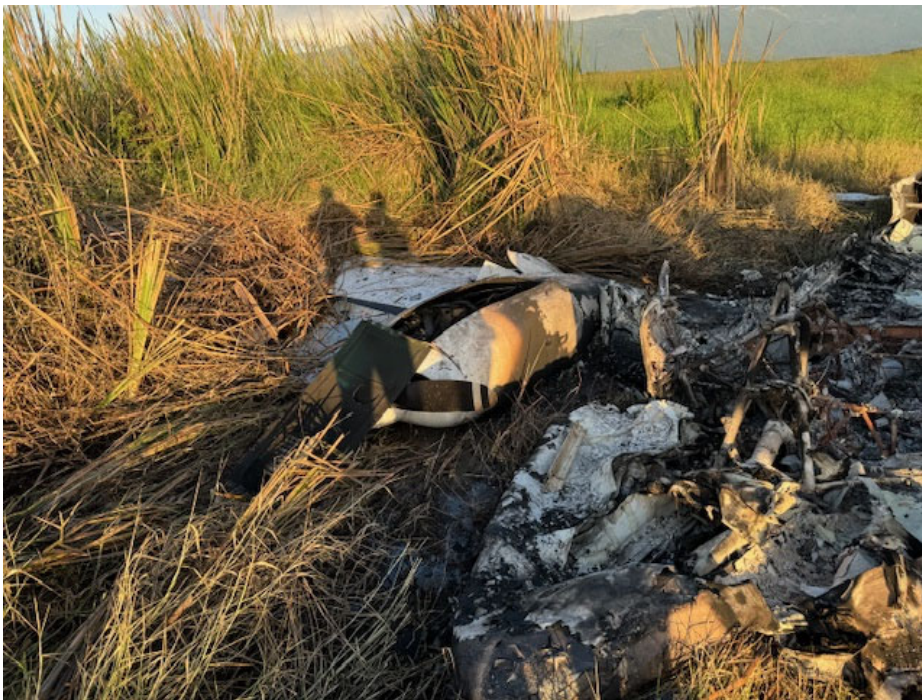
Figure 19 Wreckage of aircraft

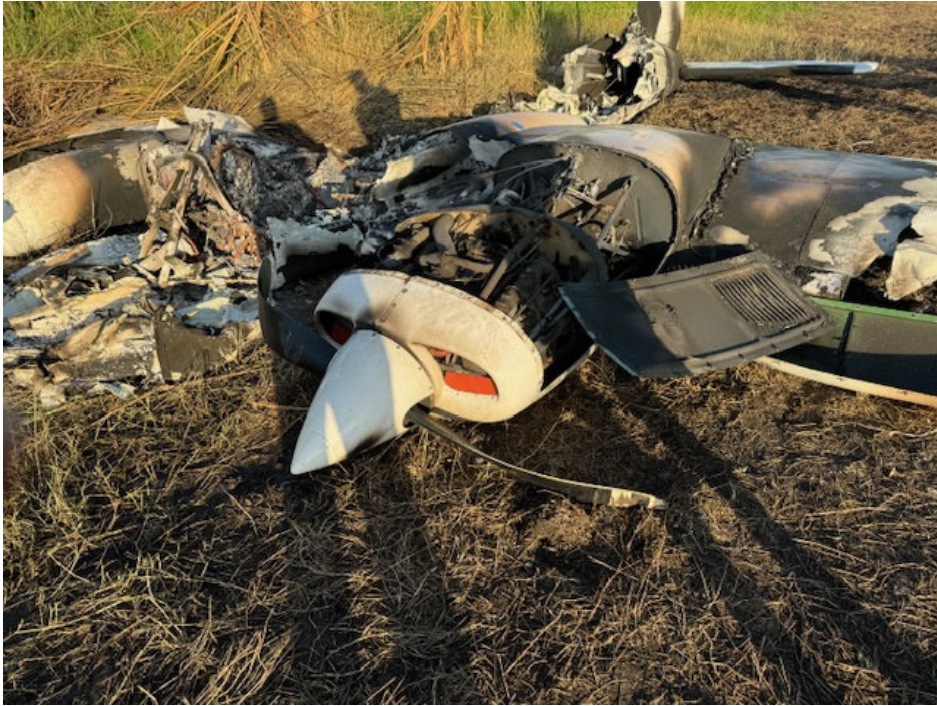
Figure 20 Wreckage of aircraft

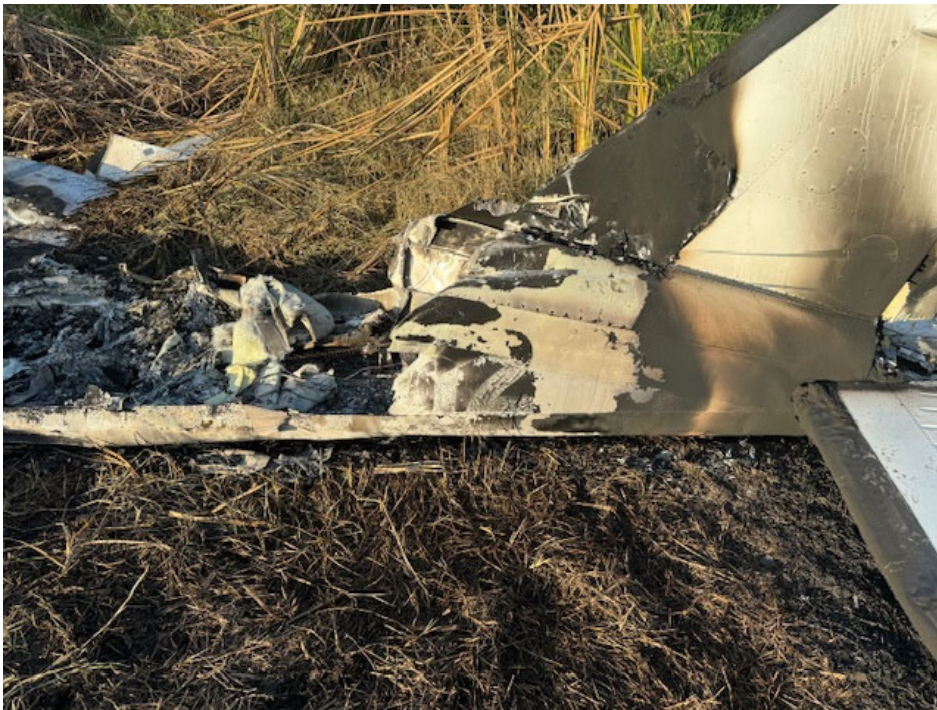
Figure 21 Wreckage of aircraft

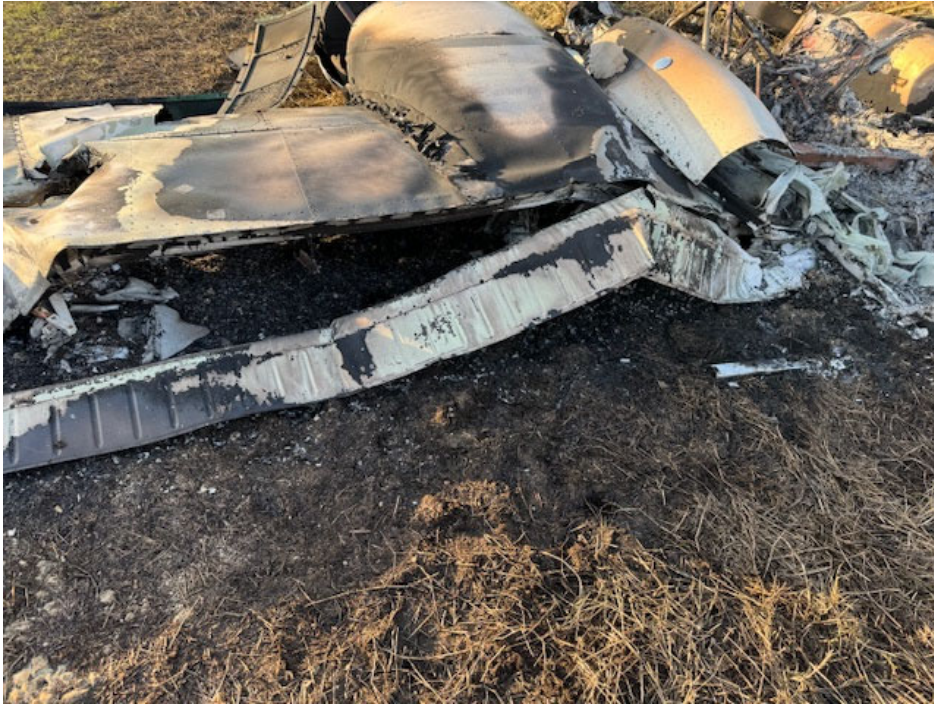
Figure 22 Wreckage of aircraft

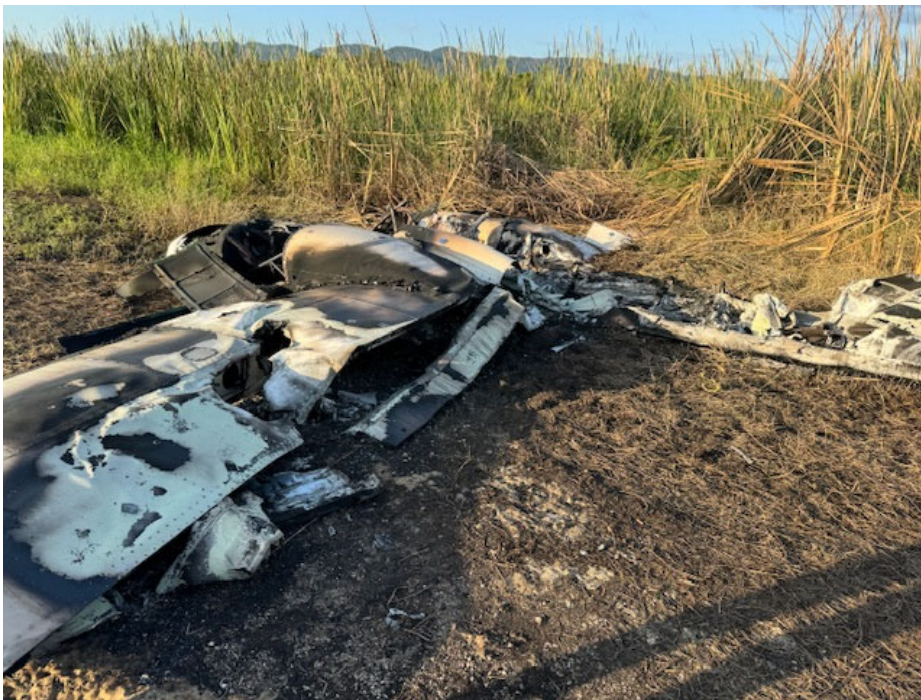
Figure 23 Wreckage of aircraft
