**AVIATION ACCIDENT INVESTIGATION REPORT**

**CRASH AFTER TAKE-OFF**

**UNIVAIR AIRCRAFT CORPORATION (FORMERLY ENGINEERING &  
RESEARCH CORPORATION) (ERCO) 415-C**

**REPORT NUMBER JA-2023-01**

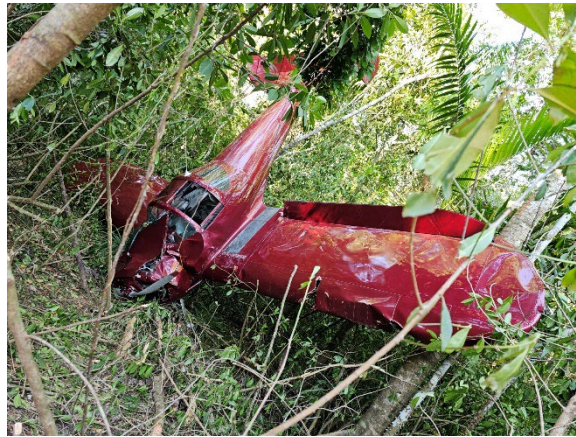
**Figure 1**

The aircraft came to rest in a nose down, near vertical position as seen in Figure 1; all four corners of the aircraft were observed at the crash site. The engine and propeller were attached to the airplane.

### **Position of Aircraft on Impact**

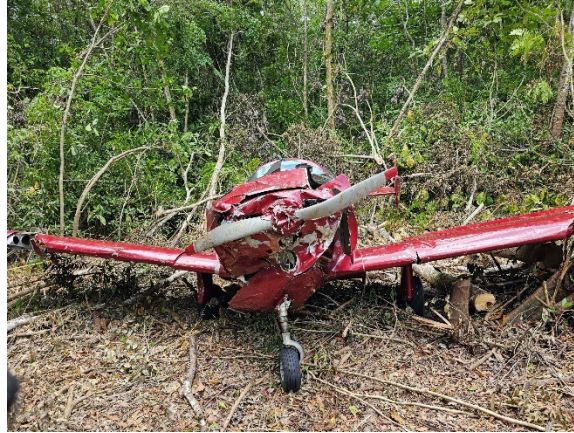
**Figure 2**

The nose cone of the propeller was crushed, and both blades were bent aft ward as seen in Figure 2. There was no evidence of scoring on the leading edge of the propeller blades. The propeller was securely attached to the engine and the bolts were secured with locking wire.

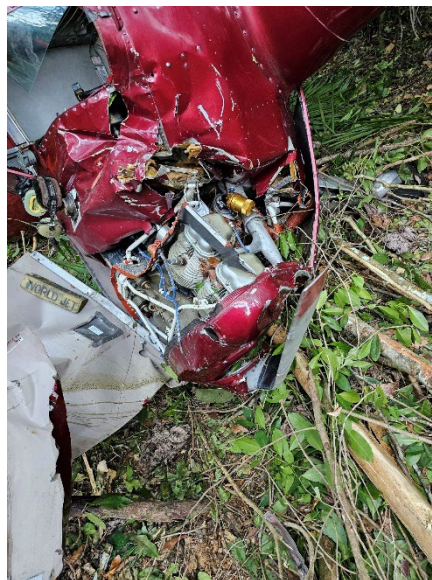
**Figure 3**

The engine cowling was partially attached to the aircraft as seen in Figure 3. The lower engine cowl was badly deformed and there was no evidence of fire damage in the engine compartment. The engine was partially attached to the firewall, and the engine mount rods were deformed. Engine control continuity was established.

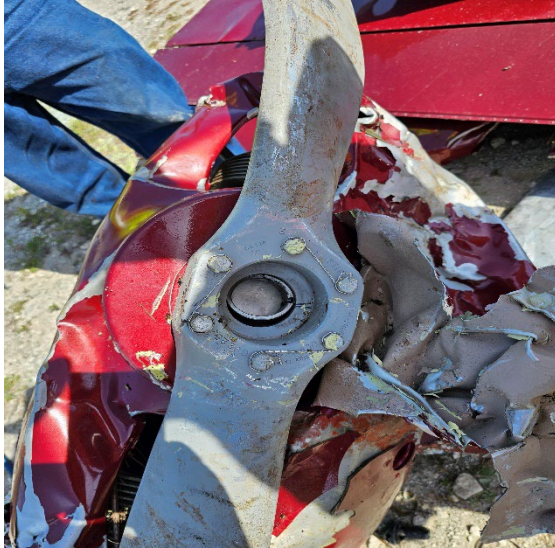
Figure 4

The propeller was securely attached to the forward section of the engine crankshaft, all attach bolts were in place and securely attached by lock wire, see figure 4. It was observed that the forward section of the crankshaft was bent, see figure 5.

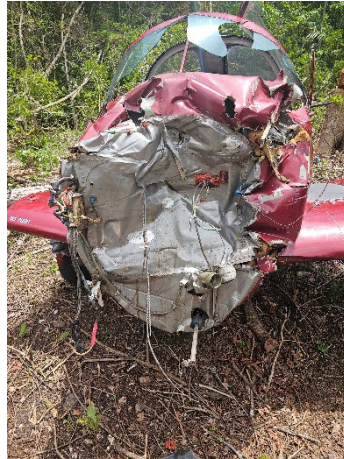
**Figure 7**

The engine firewall was deformed and displaced rearward along the airplane's longitudinal axis, the electric fuel transfer pump was securely attached to the right forward side of the firewall. The upper and lower fuselage of the aircraft just aft of the firewall was crushed and the windshield was shattered in multiple areas, see Figure 7.

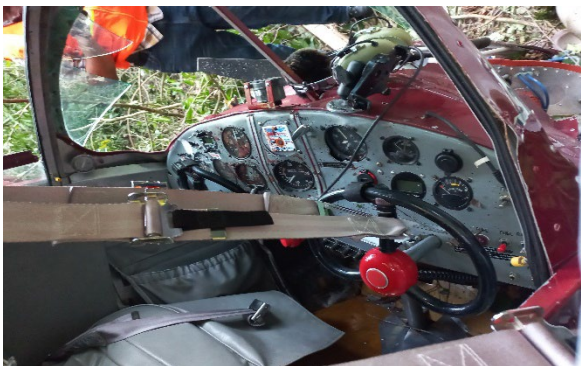
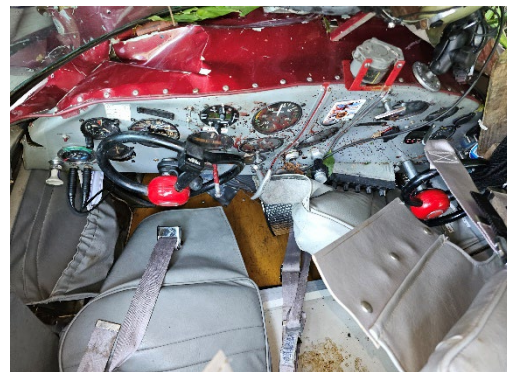
The aircraft instrument panel was slightly deformed but still intact, the glass for the Engine RPM Gauge was broken see Figures 8 & 9.

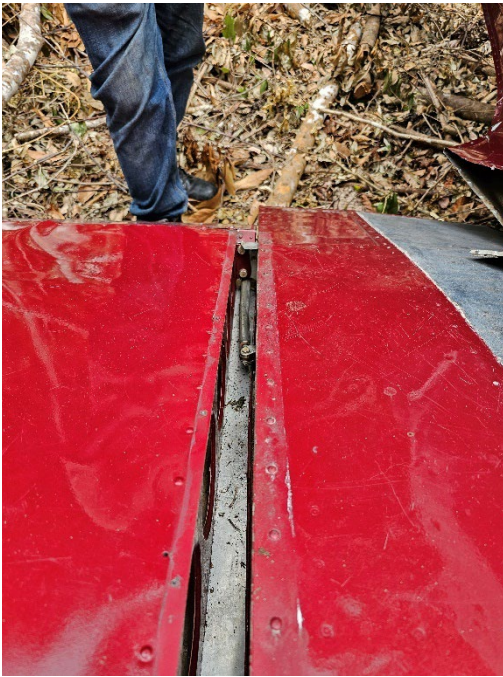
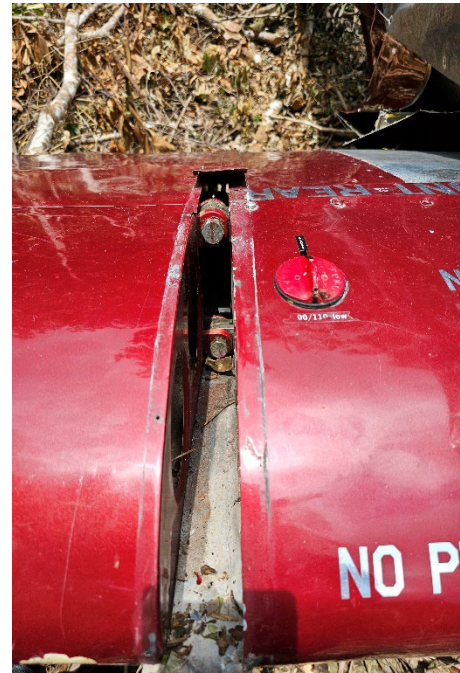
The right wing was securely attached to the center section assembly as seen in Figure 11 & 12. There was a cut approximately 13 ½ inches deep and 27 ½ inches wide along the leading-edge skin of the wing from the beam splice outer nose rib to the 8<sup>th</sup> rib of the intermediate nose. There were also various areas along the leading-edge skin and tip skin which have indentation damage. The right aileron assembly was securely attached to the rear wing beam assembly at the four hinge assemblies. The control mast to aileron bellcrank pushrod assembly was bent. Flight control surface continuity was established for the aileron. The right navigation light at the wing tip was damaged, the lens and bulb were missing.

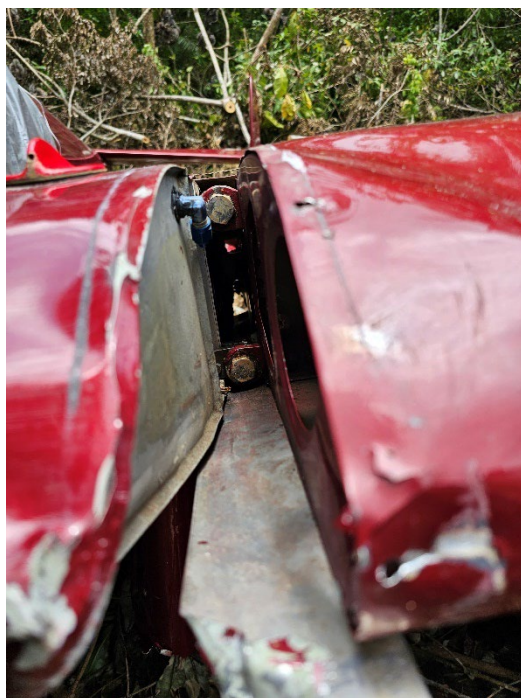
**Figure 13**

The left wing was securely attached to the center section assembly as seen in Figure 13. The skin at the wing root is separated at the lap joint. There was a cut approximately 14 inches deep and 12 inches wide along the leading-edge skin of the wing at the 6<sup>th</sup> rib of the intermediate nose. There was also a 4-inch-deep indentation damage of the leading-edge skin at the rib beam splice outer nose and various indentations along the leading edge of the wing tip skin assembly. The left aileron assembly was securely attached to the rear wing beam assembly at the four hinge assemblies, there was minor damage to the upper inboard section of the aileron. Flight control surface continuity was established for the aileron. The pitot tube assembly located at the lower left wing was securely attached with no sign of damage.

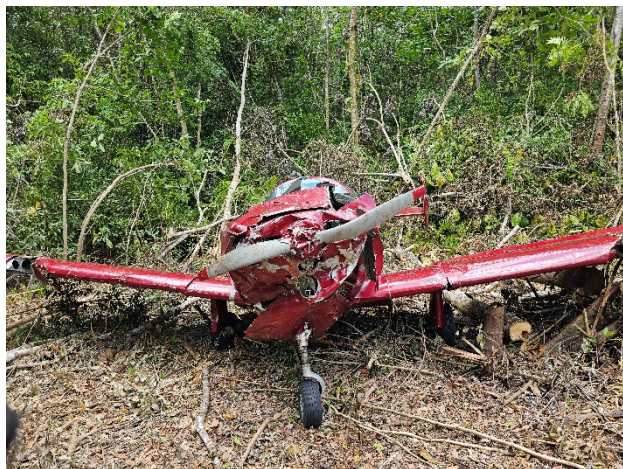
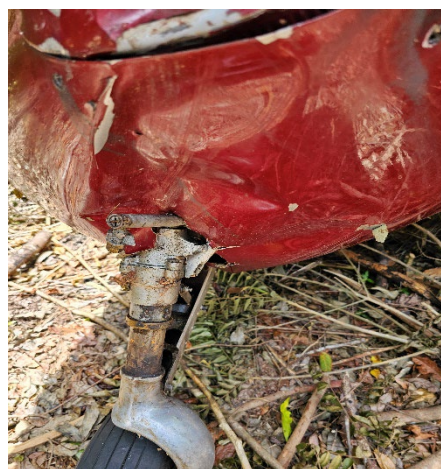
The Nose Landing Gear (NLG) was attached to the engine firewall which was displaced rearward. The torque link was attached, the strut was inflated as well as the tyre, see Figure 14. The control column to nose gear pushrod was broken at the NLG attachment, see Figure 15.

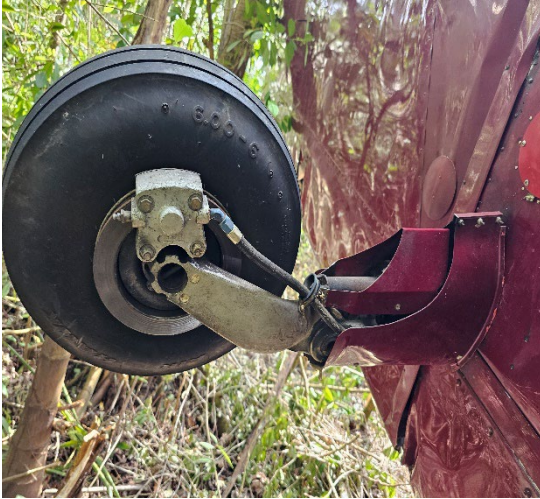
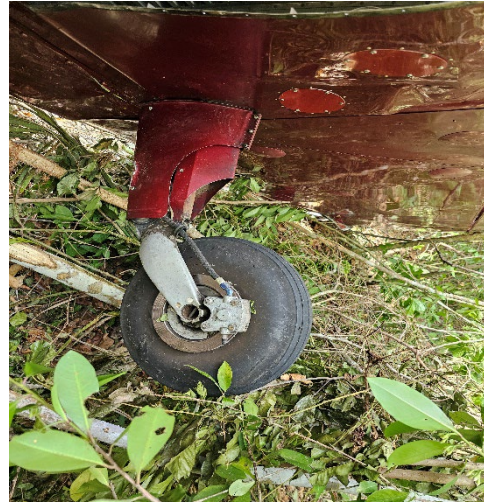
The left and right Main Landing Gears (MLG) were securely attached to the front beam of the Center Section. The torque links were attached, the struts were inflated as well as the tyres, see Figure 16 for the L/H MLG and Figure 17 for the R/H MLG.

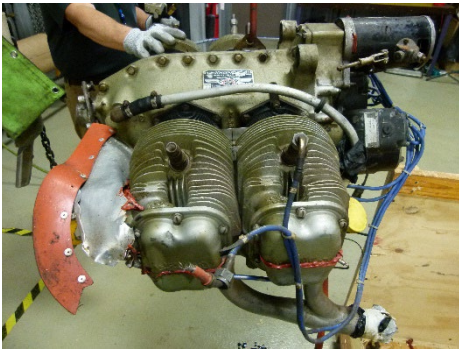
Figure 18

The exhaust system was damaged by the impact and only the runners were returned.

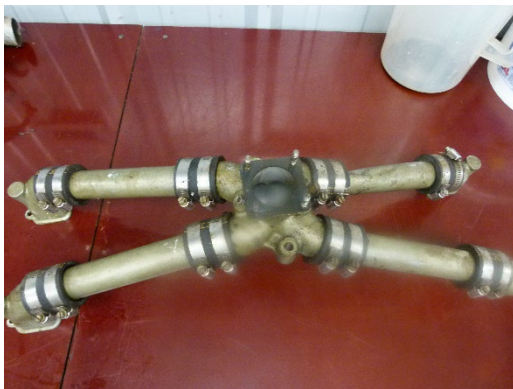
Figure 20

The induction system was intact and exhibited impact damage. See Figures 20 & 21

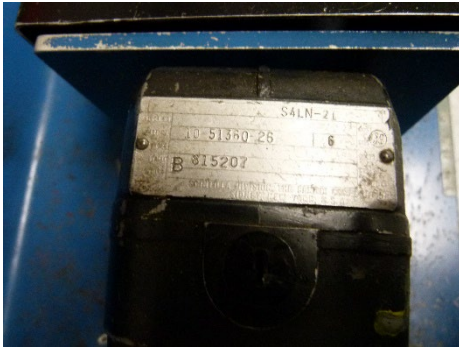
**Figure 22**

The left magneto, Manufacturer: Bendix, P/N 10-51360, S/N B815207, was test run and produced a spark across a 7mm gap. See Figures 22 & 23.

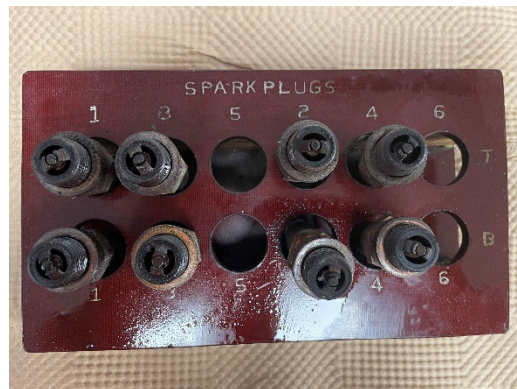
Figure 28

The spark plugs, Manufacturer: Spitfire, P/N SR-88, were worn and dirty. See Figure 28.

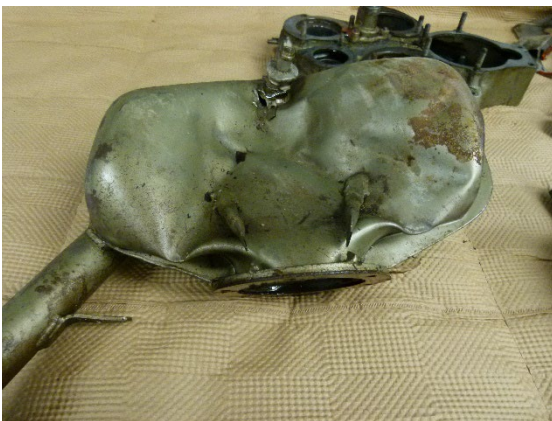
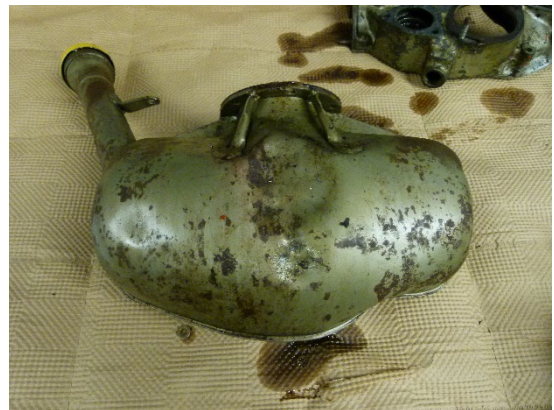
The oil sump was damaged from impact on the front side. See Figures 29 & 30.

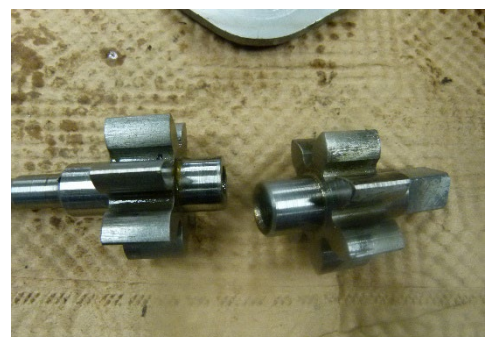
Figure 32

The oil pump exhibited normal operating signatures. See Figures 31 & 32.

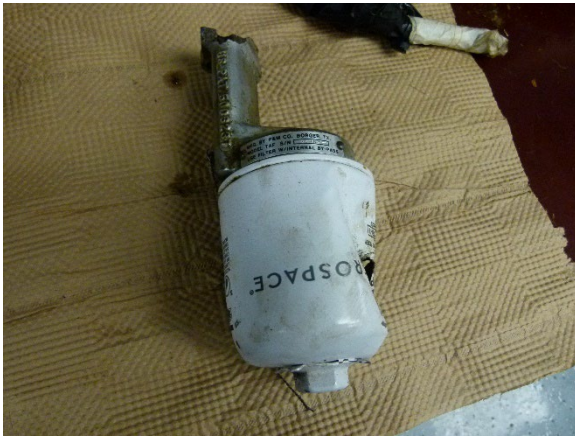
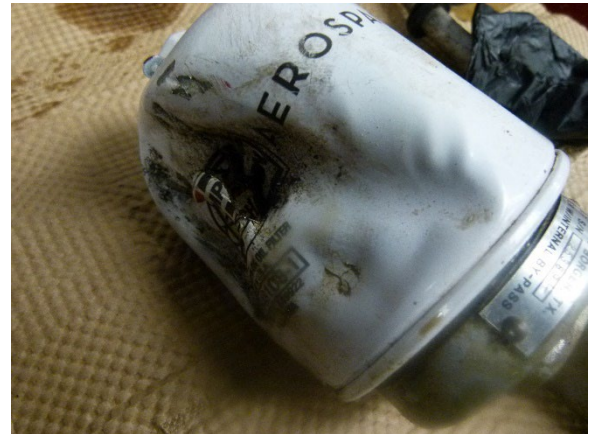
The oil filter, Manufacturer: Champion, P/N CH48108-1, was damaged from impact, breached, and was still attached to the adaptor. See Figures 33 & 34.

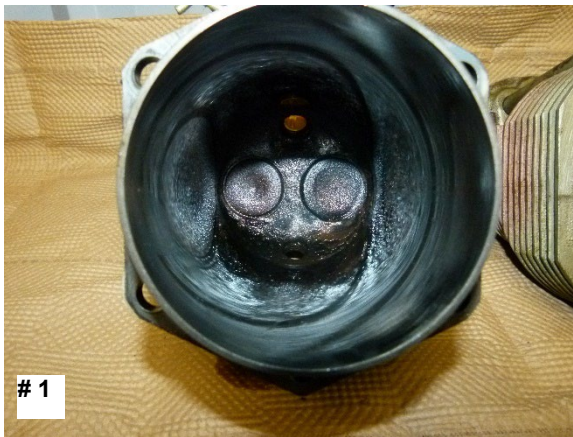
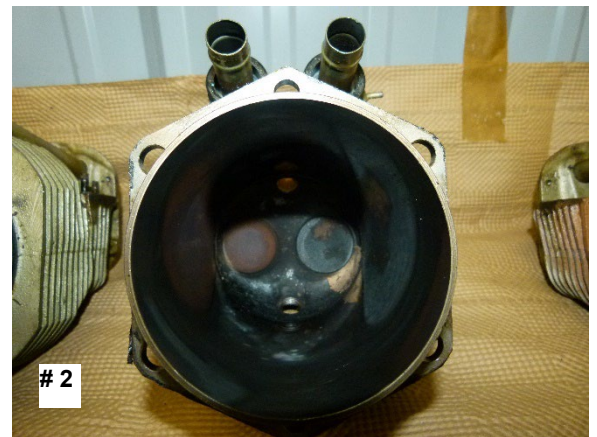
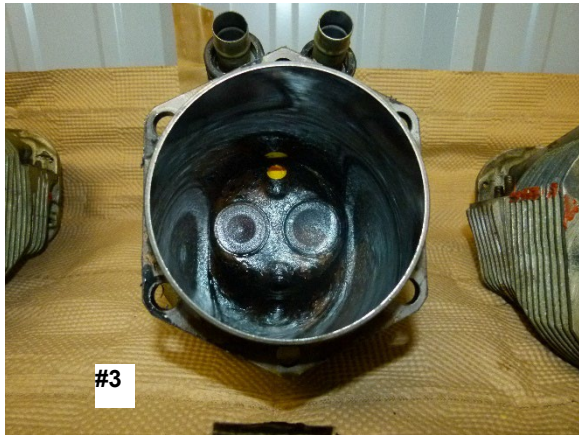
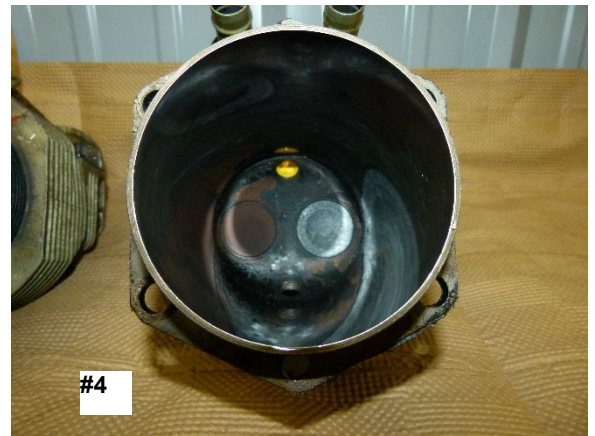
All four cylinders exhibited normal operating signatures. See Figures 35 through 38.

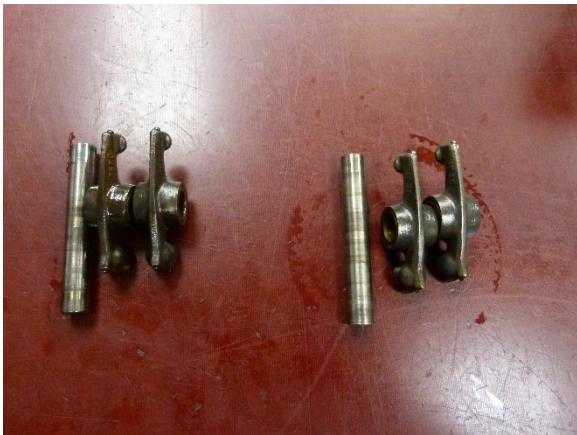
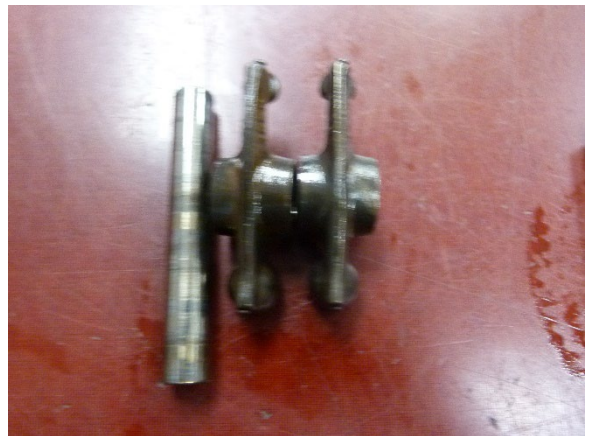
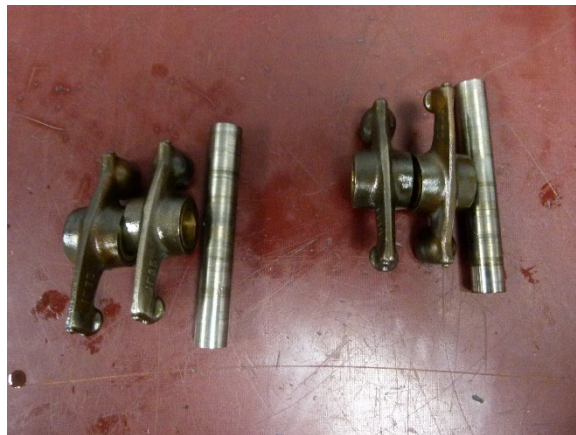
The rocker arms and shafts exhibited normal operating signatures. See Figures 39 through 41.

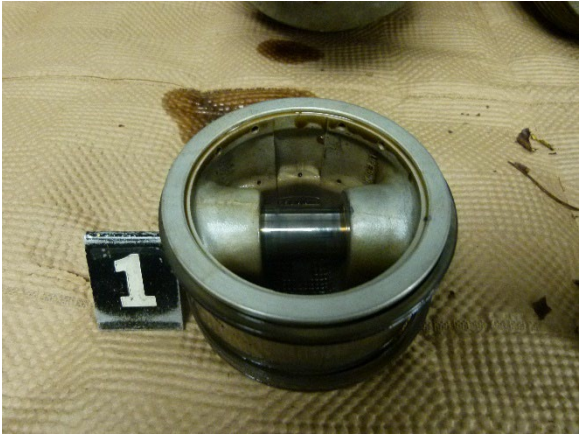
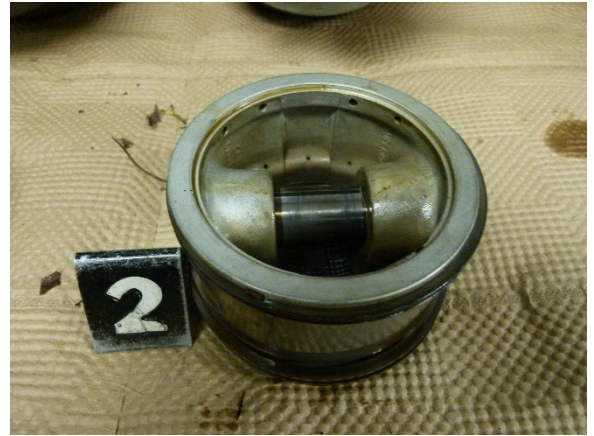
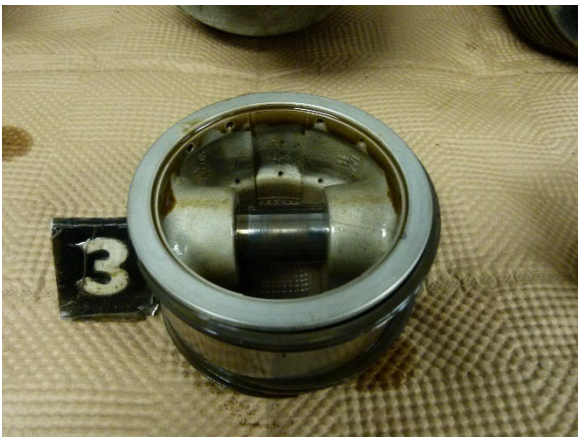
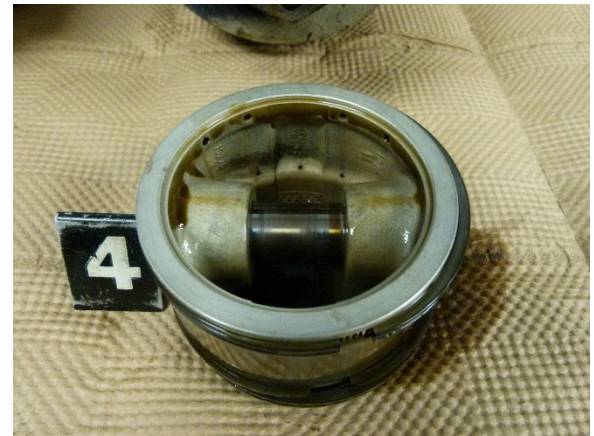
All four pistons, P/N SA530348 P .015, exhibited normal operating signatures. See Figures 42 through 45.

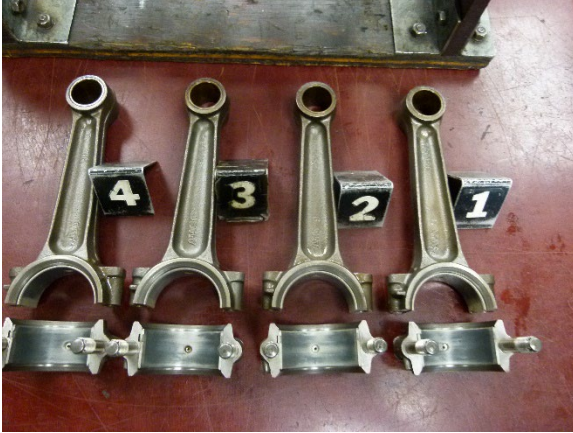
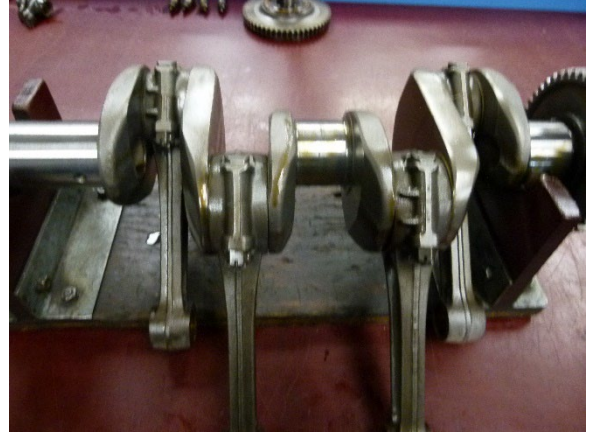
The connecting rods, P/N illegible, Forging or S/N: 530186, exhibited normal operating signatures. See Figures 46 & 47.

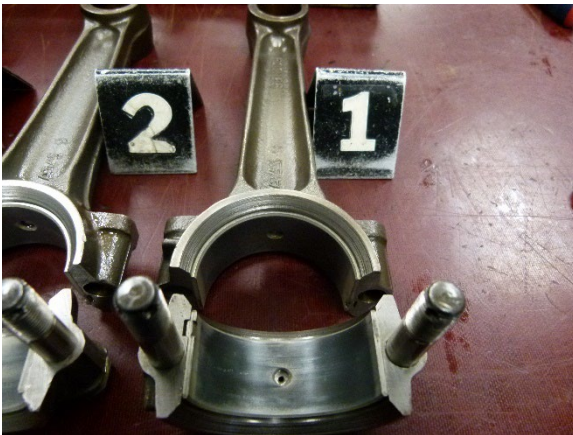
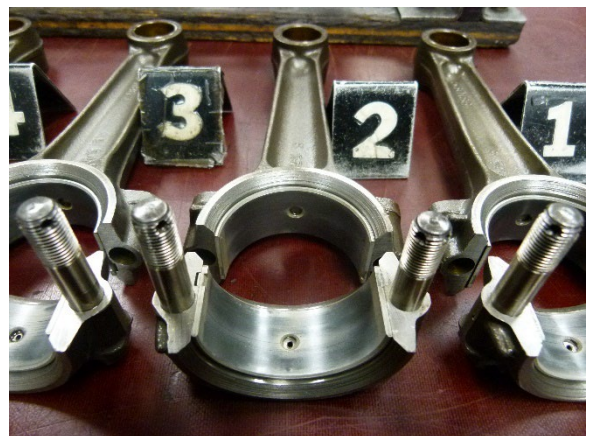
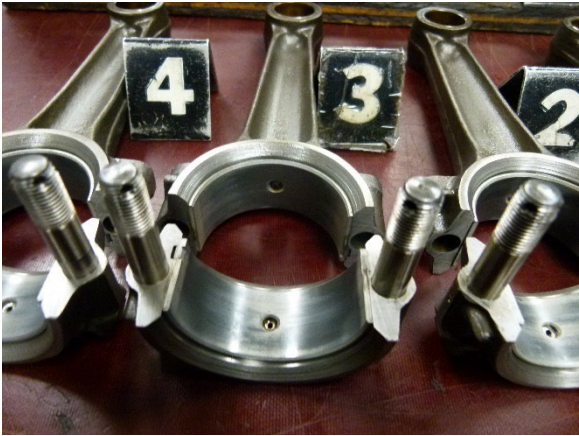
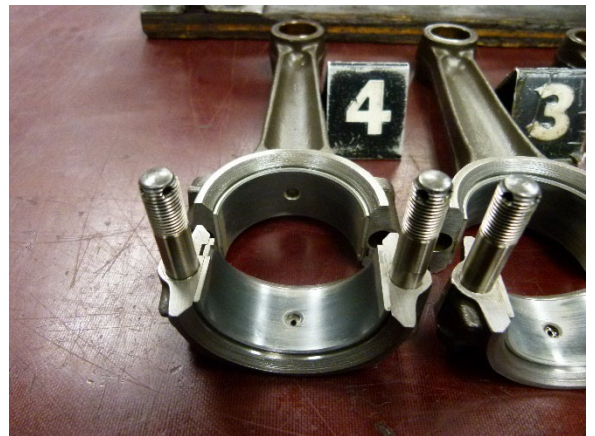
The connecting rod bearings, P/N ASC35897M.010, exhibited normal operating signatures. See Figures 48 through 51.

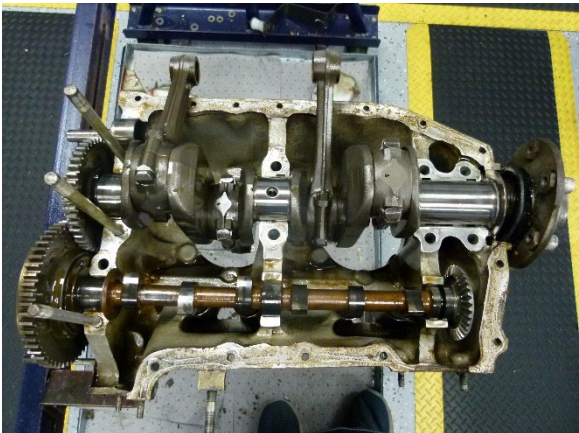
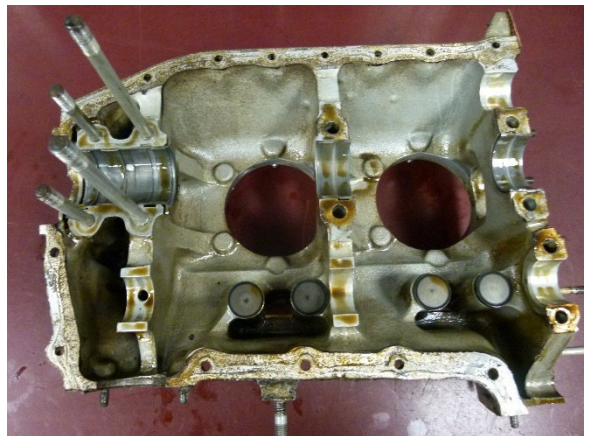
The crankcase, Casting numbers 1-3 627357 and 2-4 627358, S/N: 17, exhibited normal operating signatures. See Figures 52 & 53.

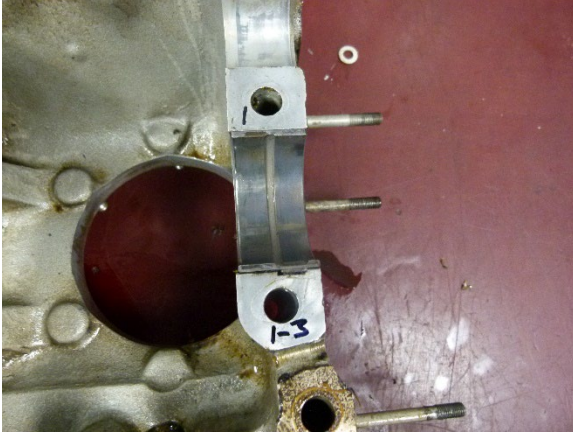
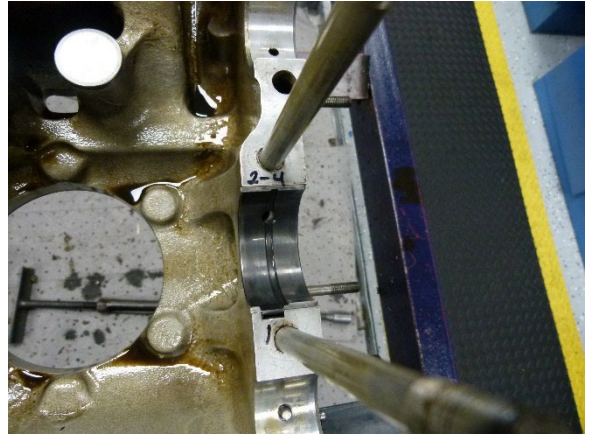
The No. 1 main bearing, P/N: 633398M.010, exhibited normal operating signatures. See Figures 54 & 55.

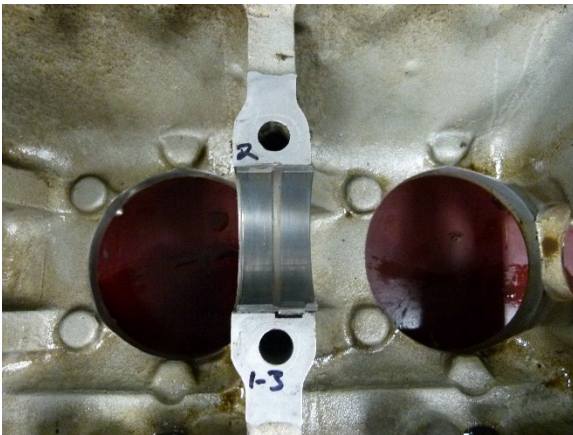
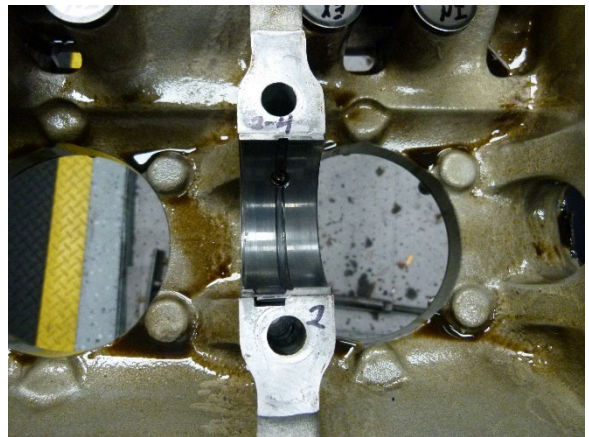
The No. 2 main bearing, P/N 633398M.010, exhibited normal operating signatures. See Figures 56 & 57.

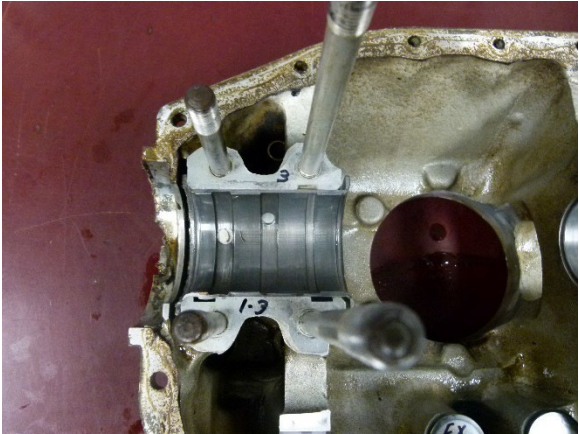
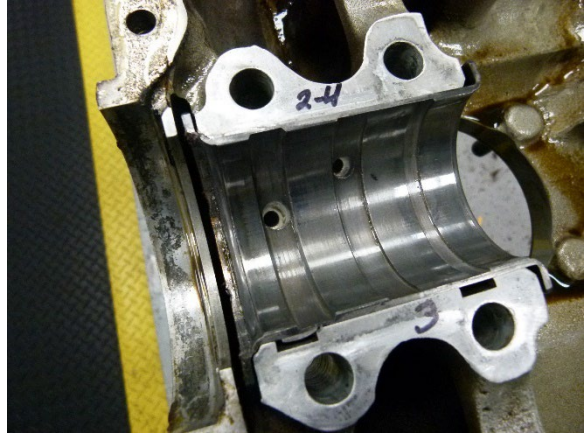
The No. 3 main bearing, P/N P/illegible, exhibited normal operating signatures. See Figures 58 & 59.

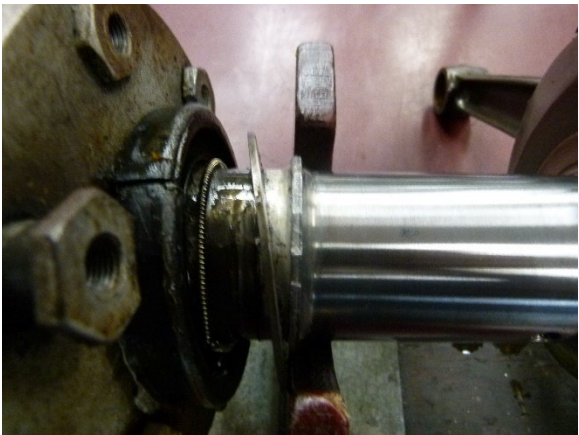
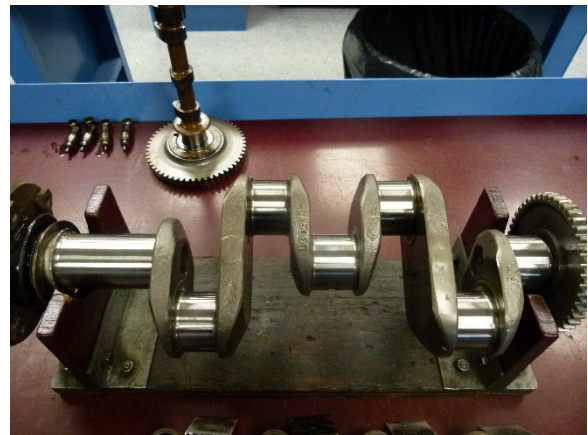
The crankshaft, Forging No.53058, S/N: illegible, the crankshaft flange and slinger ring were fractured from impact forces. The remainder of the shaft exhibited normal operating signatures. See Figures 60 & 61.

12. The engine examination revealed no evidence of preimpact catastrophic mechanical malfunction or fire.
13. The engine crankshaft flange and slinger ring were fractured from impact forces.

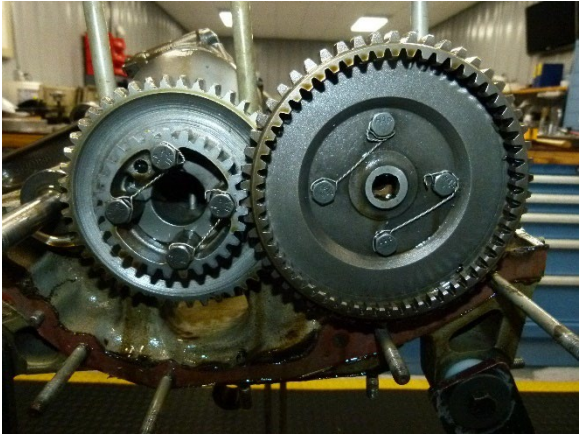
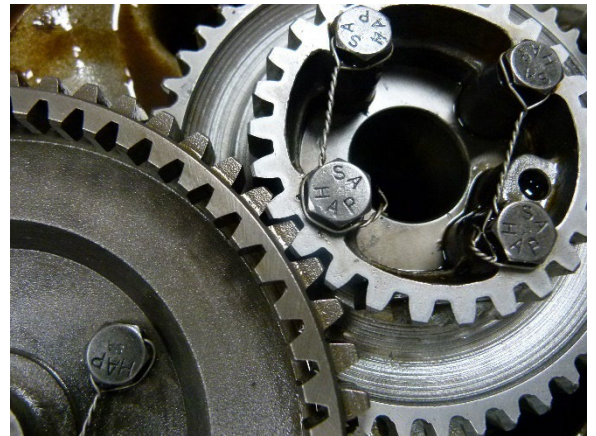
The internal was found to be correct. See Figures 62 & 63.

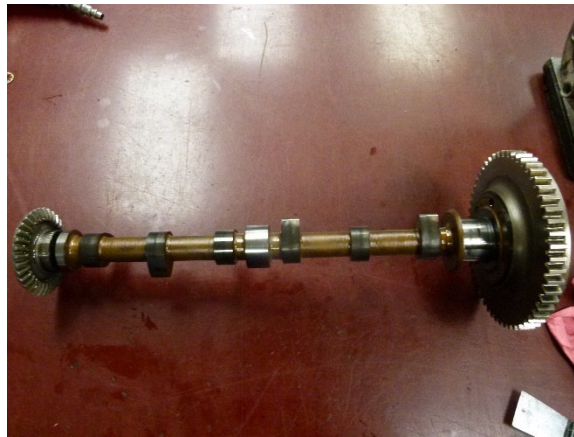
**Figure 64**

The camshaft, P/N 626608, S/N: 123037, exhibited normal operating signatures. See Figure 64.

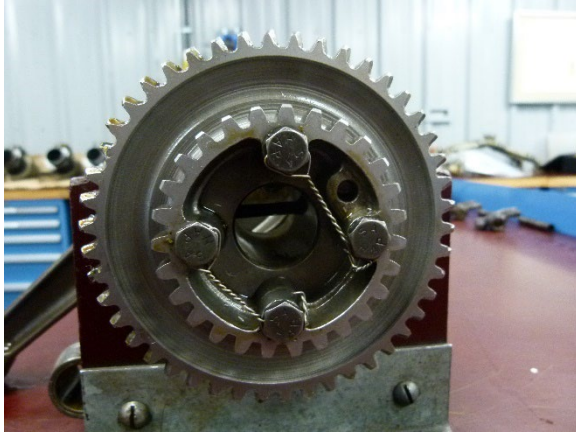
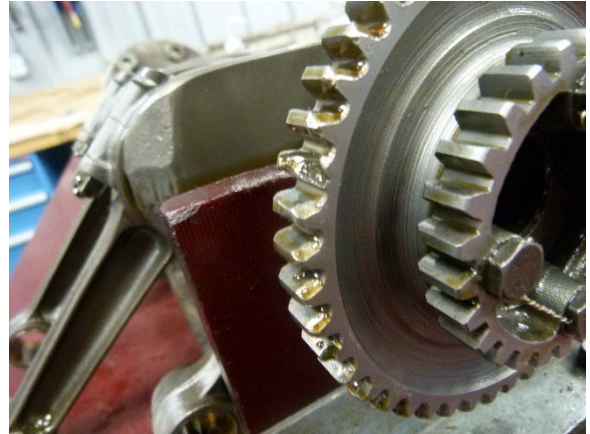
The gears exhibited normal operating signatures. The starter gear had damage from the engagement of the starter. The damage was most likely caused by engagement of the starter while the engine was running. See Figures 65 & 66.

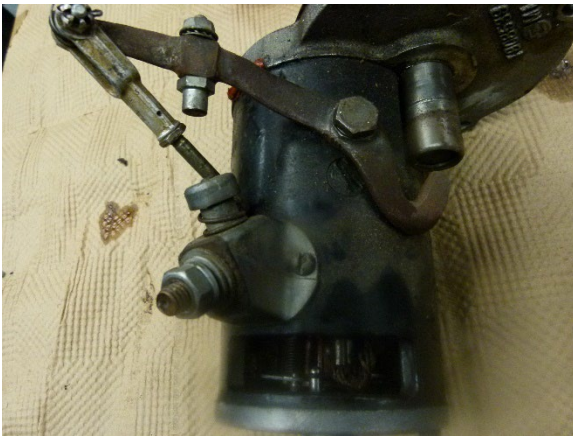
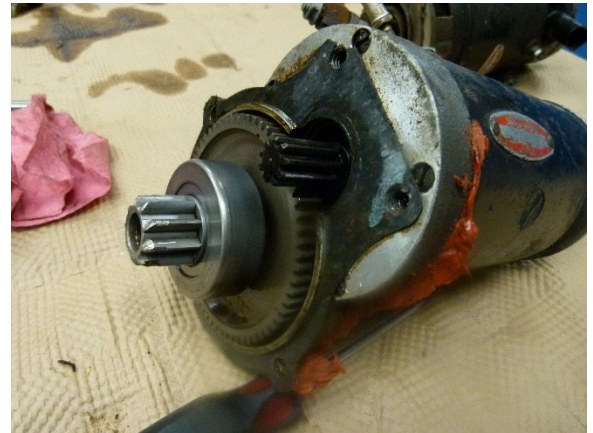
The starter, Manufacturer: Delco-Remy, P/N 1109656, S/N: 45570, exhibited normal operating signatures. There was damage to the input gear. See Figures 67 & 68.

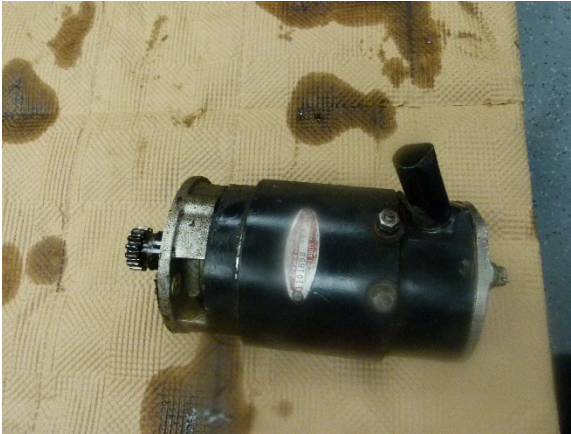
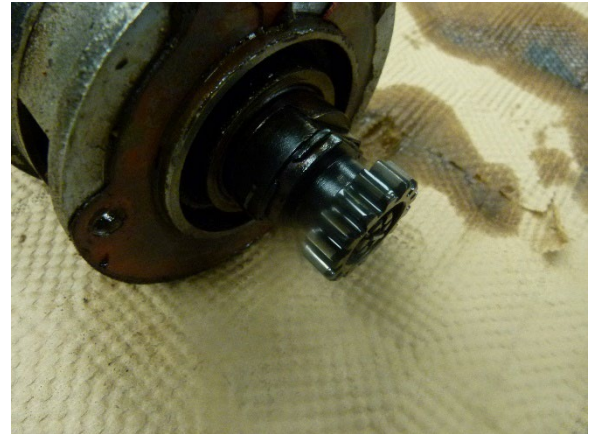
The generator, Manufacturer: Delco-Remy, P/N illegible, S/N: 1101889, exhibited normal operating signatures. See Figures 69 & 70.

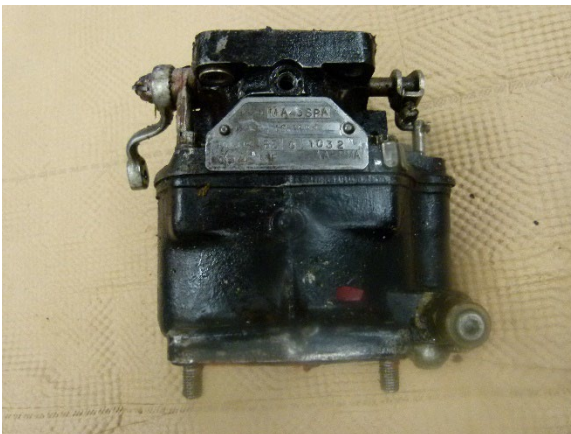
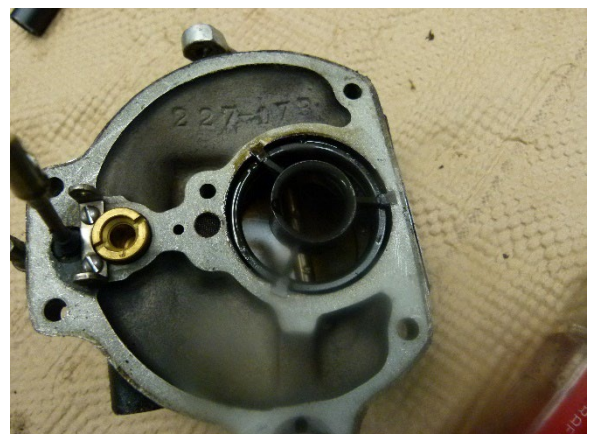
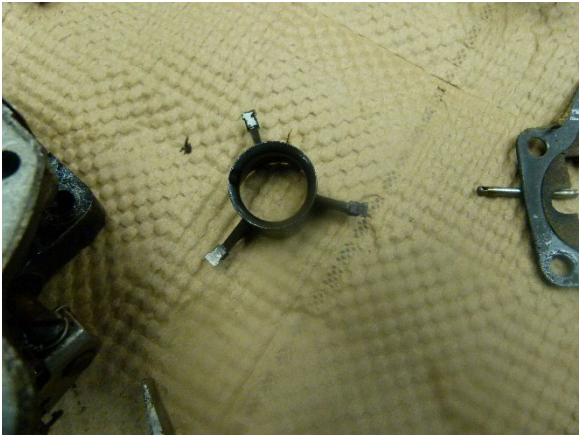
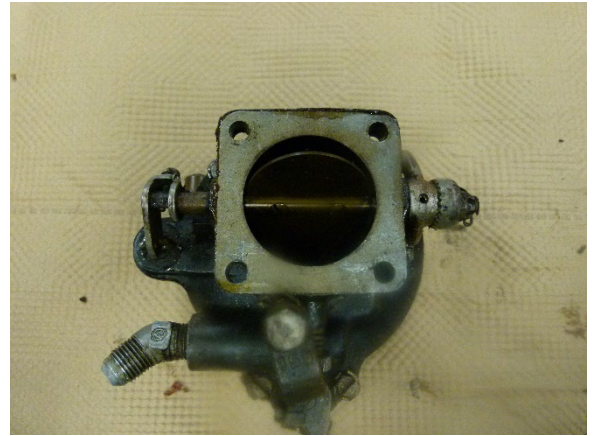
The carburetor, Figure 71, Manufacturer: Marvel-Schebler, P/N MA-3SPA, S/N: 1032, was disassembled and was clean and intact. The carburetor had a two-piece venturi installed. The FAA AD 98-01-06 is applicable to this carburetor. The purpose of the AD is to prevent disruption of fuel flow to the engine resulting in failure to attain rated power, power loss in flight and forced landings. The AD calls for the inspection of the two-piece venturi at each annual, 100-hour, or progressive inspection to determine if the primary venturi, Figures 72 & 73 is loose or missing. Installing a one-piece venturi constitutes terminating action for the repetitive inspection requirements of the AD. The fuel inlet screen (finger strainer), Figure 75, was not installed in the carburetor, the fuel inlet fitting was installed directly in the carburetor as seen in Figure 74.

14. The fuel inlet strainer assembly (finger stainer) was not installed on the carburetor for the engine.
15. The test of the engine ignition system revealed that it was in working condition.

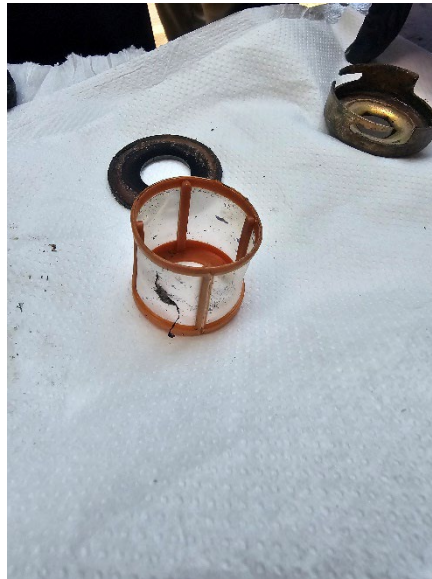
**Figure 76**

The Facet electric fuel pump (FAA PMA P/N SS10603-1) was tested in accordance with instructions from Alpha Aviation Inc., the current STC Holder for FAA STC No. SA2628WE. The findings of the test revealed that the pump was found to be in working condition. There was a light amount of debris found on the fuel pump screen, as seen in Figure 76.
