## Jamaica Civil Aviation Authority

### Aviation Occurrence Report Number JA-2021- 01

**AVIATION OCCURRENCE REPORT**  
**ROCKY POINT- CLARENDON**  
**SABRELINER 60 - REGISTRATION XB-JMR**  
**JANUARY 23, 2021**

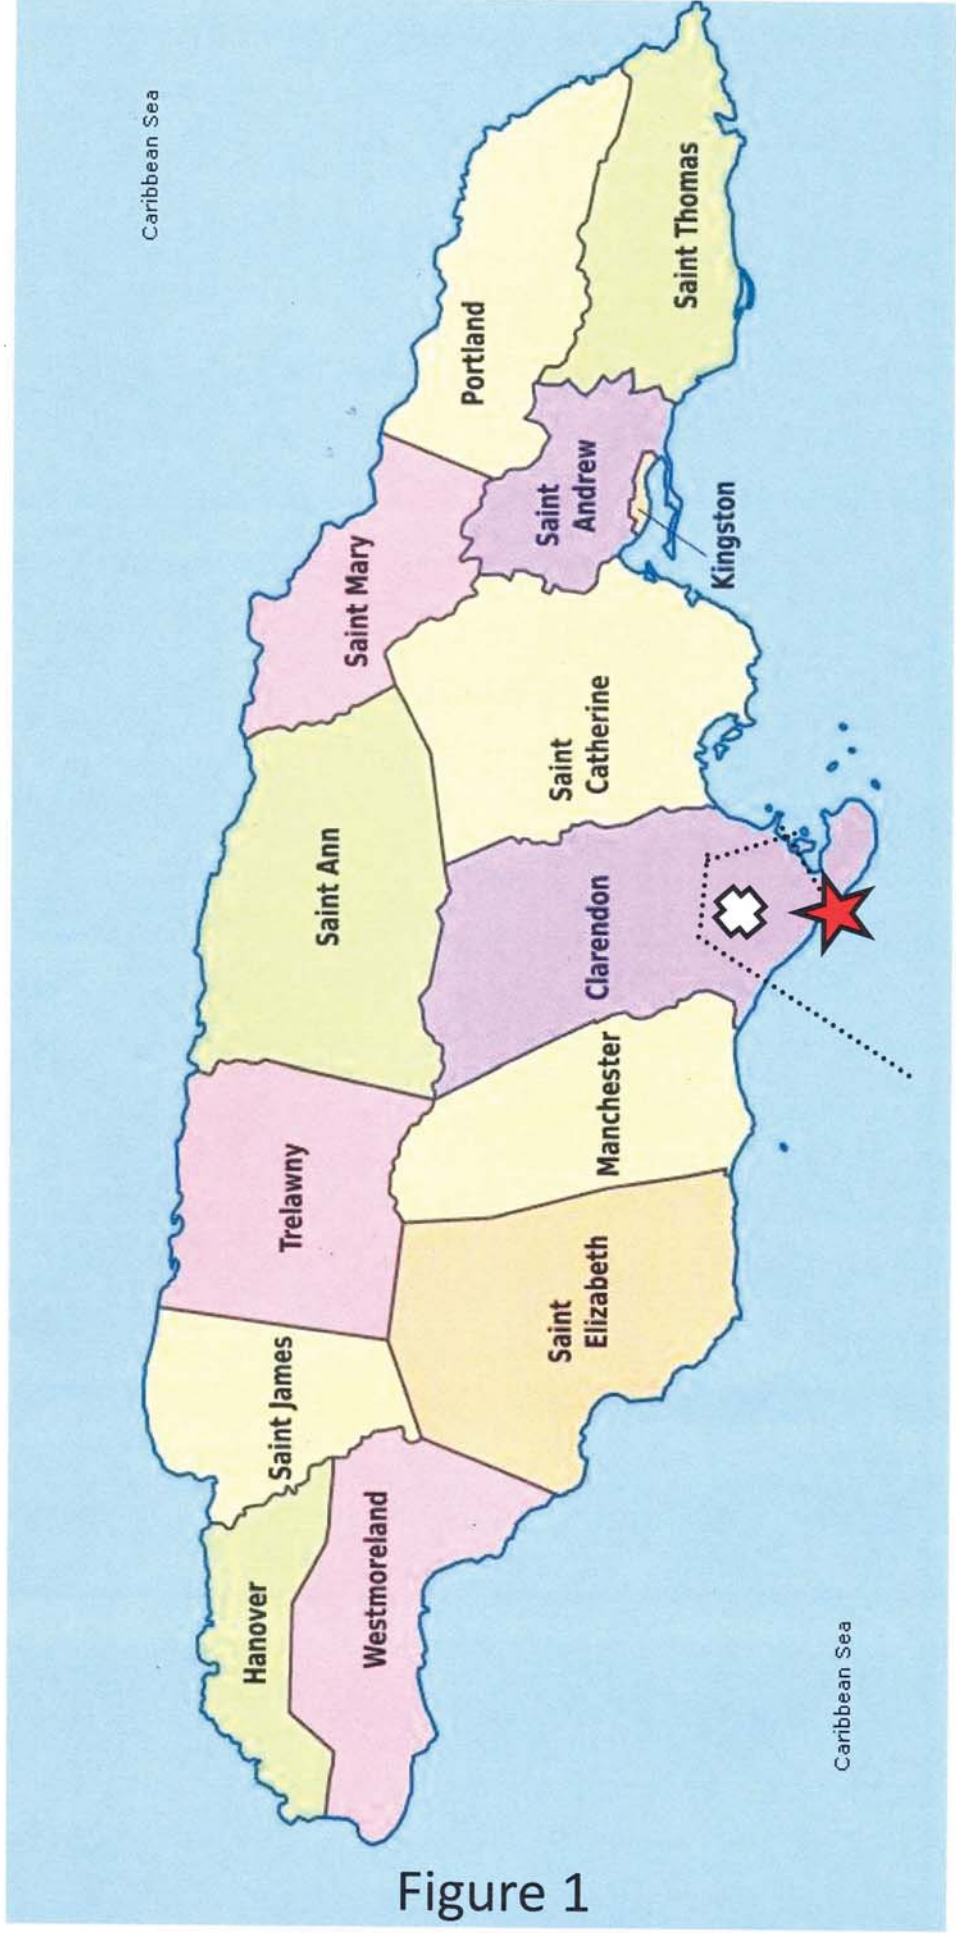
Figure 1

1.4 The Aircraft impacted the shoreline south-east of the White Sand Beach area of Rocky Point in Clarendon (17°45'55.69"N 77°15'42.94"W) at approximately 6:39pm local. (*Radar Tapes – January 23, 2021*). (Fig. 1- Rocky Pont).
