AVIATION ACCIDENT REPORT FOR

CESSNA 152

REGISTRATION 6Y-JGA

DRAFT REPORT

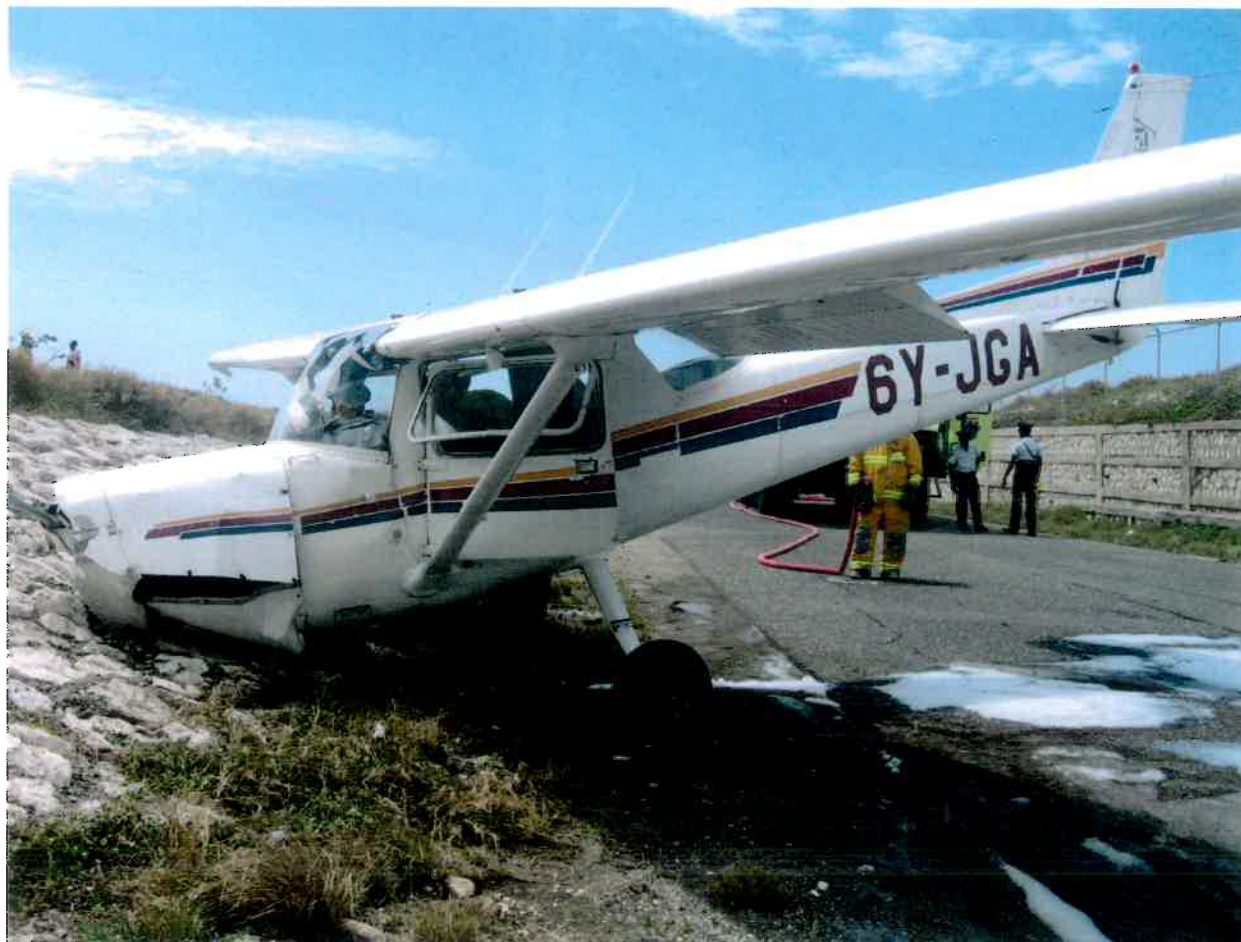
The aircraft sustained major damage to the fuselage nose section. The skin on the aircraft fuselage just aft of the doors showed evidence of wrinkles, and the passenger door had evidence of deformation. The right wing tip sustained impact damage at the leading edge. The windshield was shattered and the compass broke loose and was thrown forward of the aircraft. The nose landing gear snapped at the attachment point.

One propeller blade was bent back onto the lower right side of the engine and the other blade was undamaged. The damage to the propeller was consistent with it turning at impact.

The entire engine shifted aft into the firewall. The crankshaft flange for the attachment of the propeller was bent and the generator was damaged. The carburetor body was broken off at the neck which resulted in all the fuel draining from the aircraft.

Photo 1. Major damage to fuselage nose section, nose landing gear and propeller
