**AVIATION ACCIDENT INVESTIGATION REPORT**

**CRASH AFTER TAKE-OFF**

**UNIVAIR AIRCRAFT CORPORATION (FORMERLY ENGINEERING &  
RESEARCH CORPORATION) (ERCO) 415-C**

**REPORT NUMBER JA-2023-01**

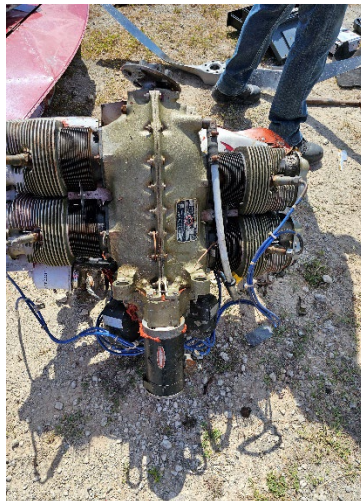
Figure 6

All four cylinders were firmly attached to the crankcase, and all eight spark plugs were installed in the cylinders with their leads attached. Both magnetos and the starter were securely attached to the accessory gearbox, as seen in Figure 6.

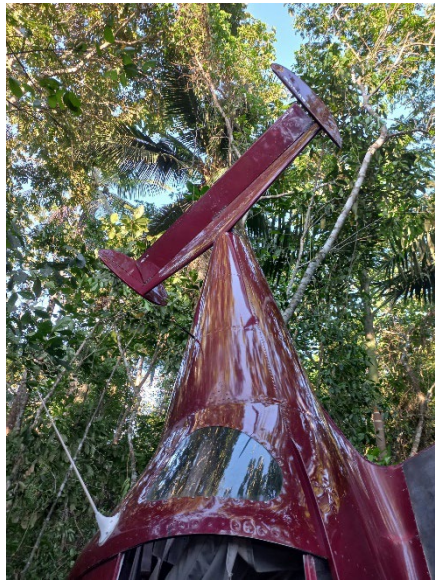
**Figure 10**

The aft fuselage and the tail cone assembly were intact, the control mast support and flight control cable runs were securely installed, no sign of damage was observed in these areas. The stabilizer assembly was securely attached to the empennage of the aircraft. The elevator assembly along with both fin assemblies were securely attached to the stabilizer assembly. Both rudder assemblies were securely attached to the fin assemblies as seen in Figure 10. Flight control surface continuity was established for the elevator, rudders, and elevator trim tab.

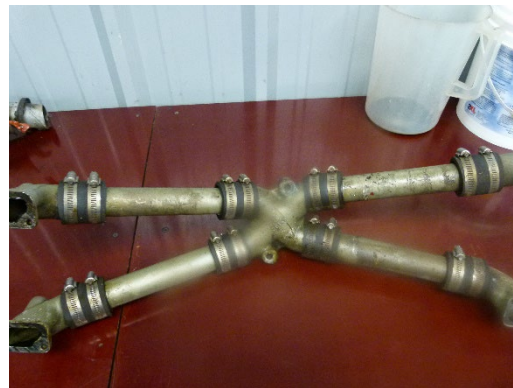
Figure 21

The induction system was intact and exhibited impact damage. See Figures 20 & 21

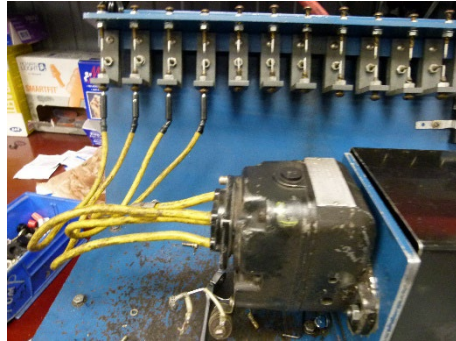
**Figure 23**

The left magneto, Manufacturer: Bendix, P/N 10-51360, S/N B815207, was test run and produced a spark across a 7mm gap. See Figures 22 & 23.

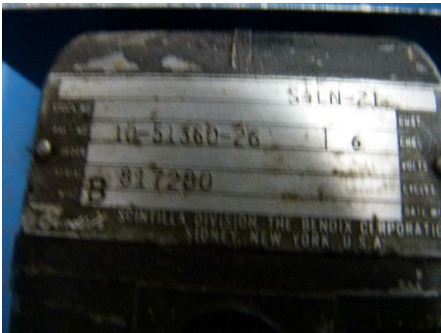
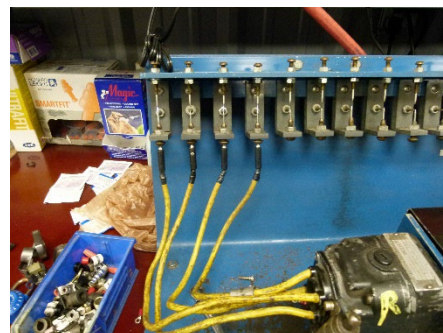
The right magneto, Manufacturer: Bendix, P/N 10-51360-26, S/N B817280, was test run and produced a spark across a 7mm gap. See Figures 24 & 25.

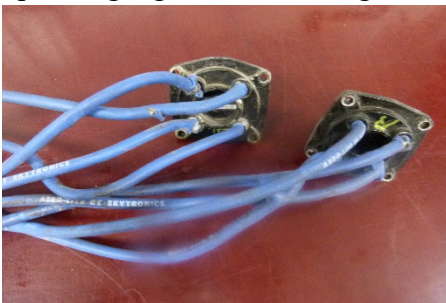
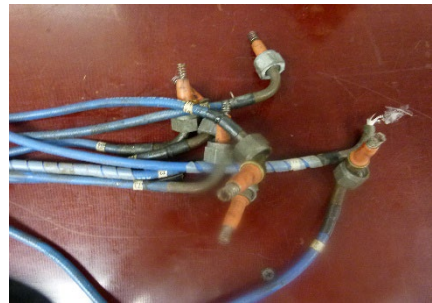
The ignition harness, Manufacturer: Skytronics, P/N C2-IAR11, exhibited normal operating signatures. See Figures 26 & 27.

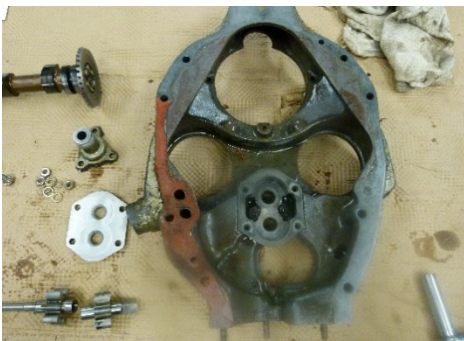
Figure 31

The oil pump exhibited normal operating signatures. See Figures 31 & 32.
